St. Asaph Flood Risk Management Scheme Case Study – KS2/3

St. Asaph

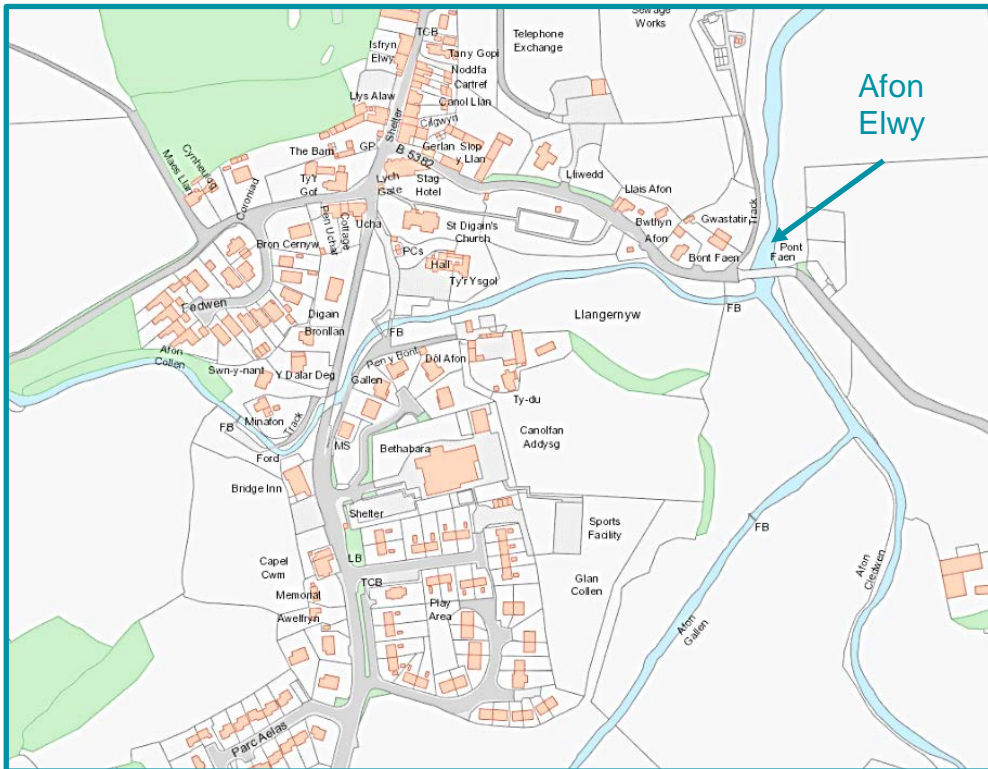
Figure 1 – map showing the Rivers Gallen, Collen and Cledwen meeting at Llangernyw to form the River Elwy

The River Elwy, a tributary of the River Clwyd comes into existence in the village of Llangernyw (South-west of St.Asaph) as three rivers converge to form the Elwy – Afon Gallen, Afon Collen and the Afon Cleddwen - see **Figure 1**.

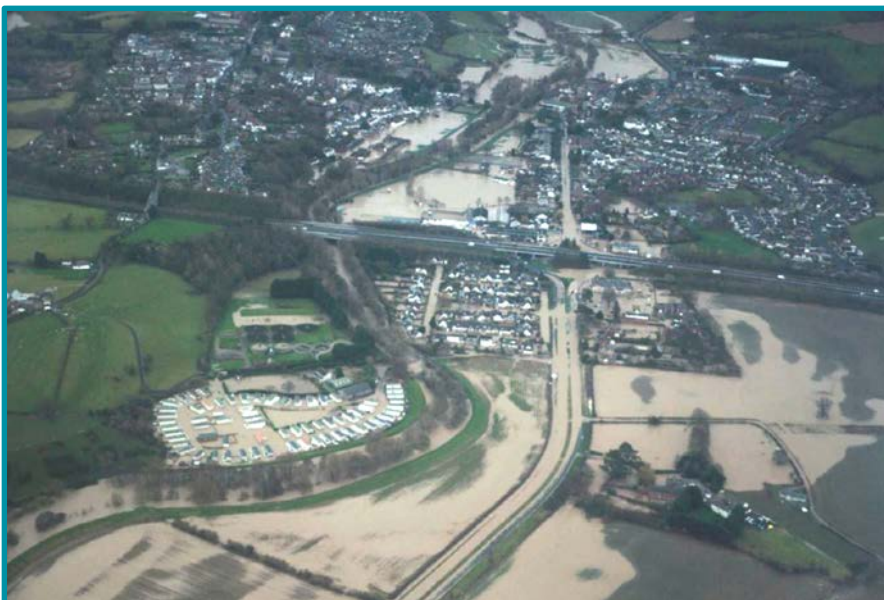
Figure 4 – flooding at St. Asaph

The flooding in November 2012 occurred when prolonged, intense rainfall fell over the catchment. During the early hours of Tuesday the 27th November 2012, the defences were overwhelmed when the Elwy rose 3 metres above its normal level. 322 homes, 32 businesses and 70 caravans within the city were flooded. A flood depth of 0.8 metres was recorded and the floods resulted in one tragic fatality. **Figure 4.** demonstrates the extent of flooding experienced by St.Asaph.

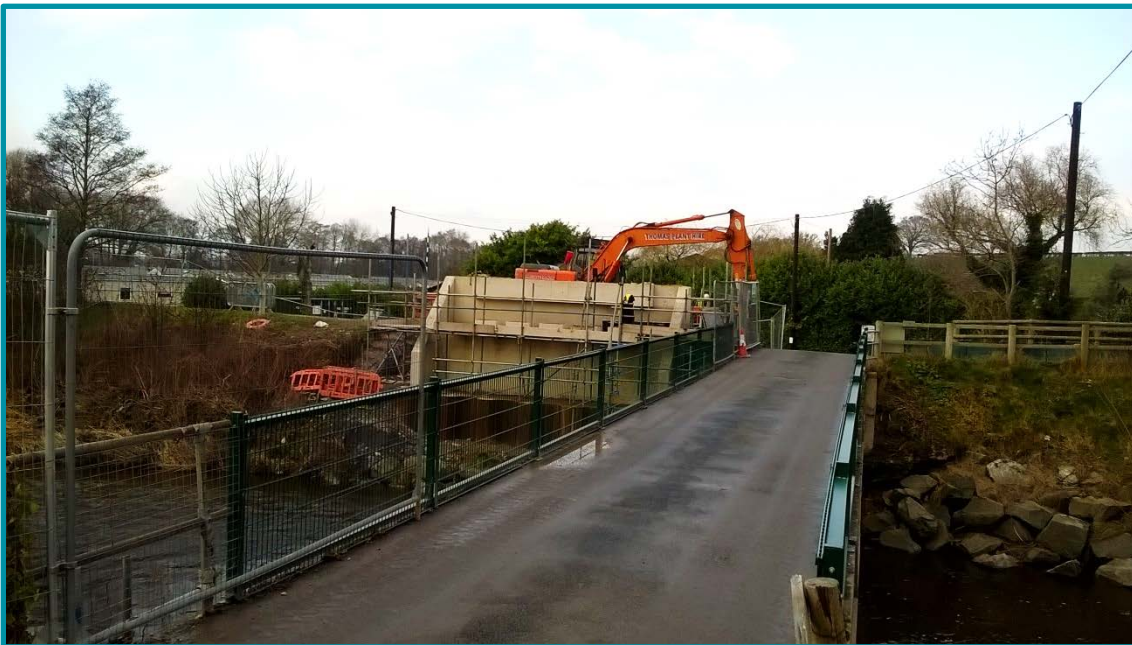
Figure 8 – work in progress to replace Spring Gardens Bridge

Following the floods in 2012 it was decided that a new flood risk management scheme was required to reduce both the present day risk of flooding in St Asaph and to allow for it to be managed for the effects of future climate change. It was agreed to raise the existing flood defences and replace the Spring Gardens Bridge.

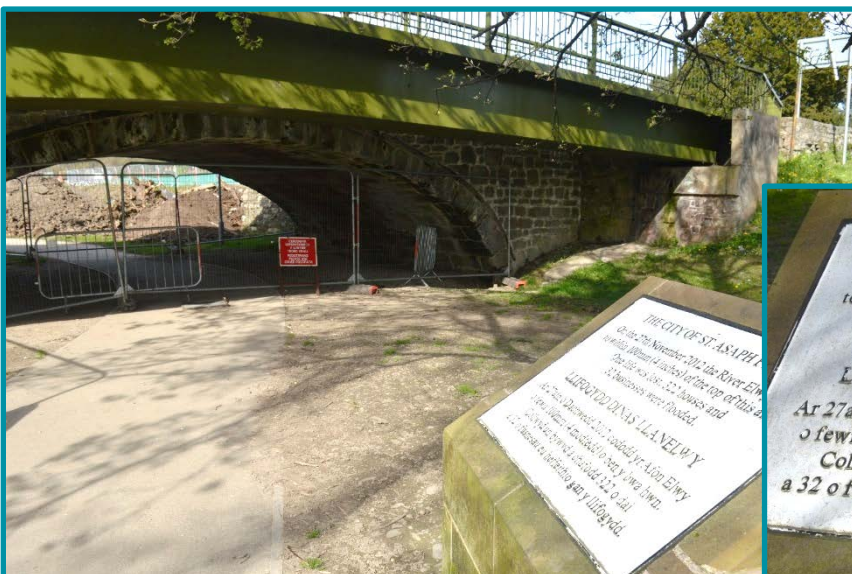
Figure 9 – Above - work in progress by the Old Bridge at St. Asaph

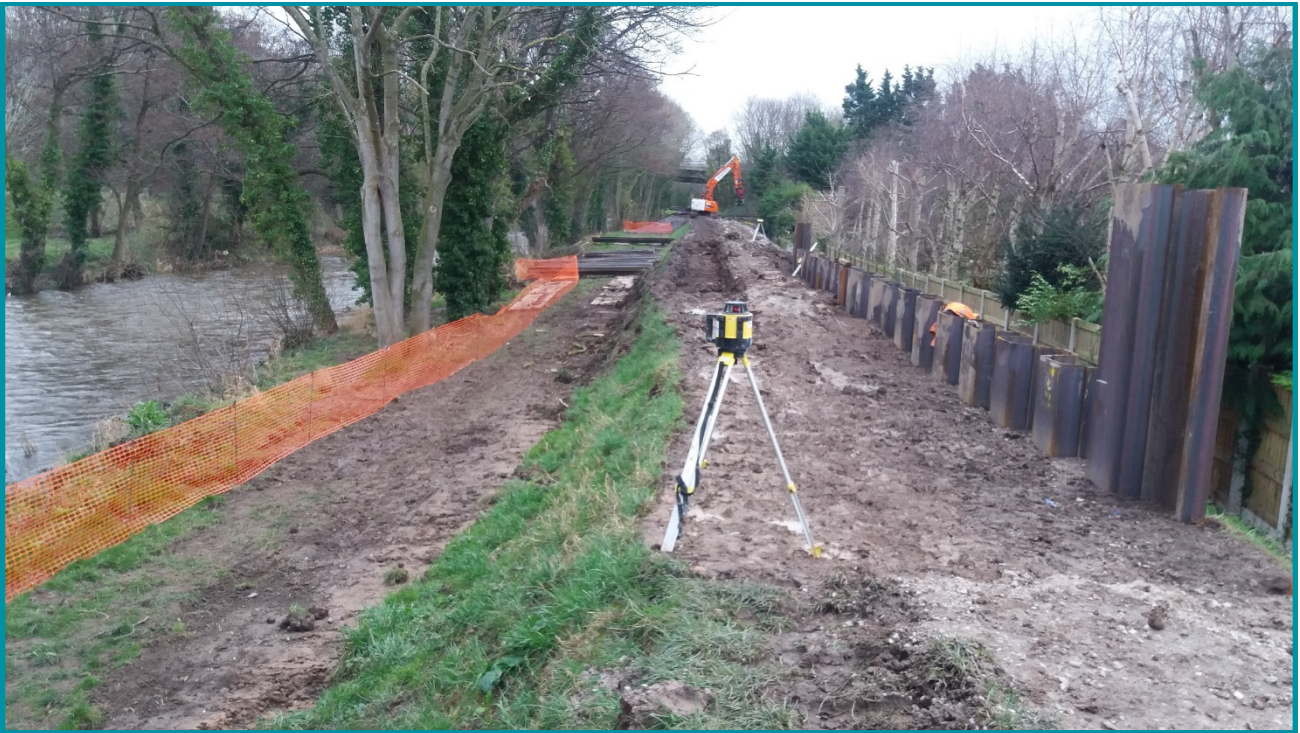
Figure 11 - several trees had to be removed along the river corridor to allow access for machinery to begin work on raising existing defences

The key negative impact resulting from the Scheme has been tree loss along the river corridor to enable the construction of the Scheme. Approximately 80-90 trees were removed however more new trees were planted to compensate for the loss.
