# Assessment of physical habitat condition and development of restoration actions for the River Wye SAC in Wales

S. Thomas, J.A. Constantine, I. Durance, S.W. Griffiths, M. Munday, S.J. Ormerod, N. Small & I.P. Vaughan

NRW Evidence Report No. 51

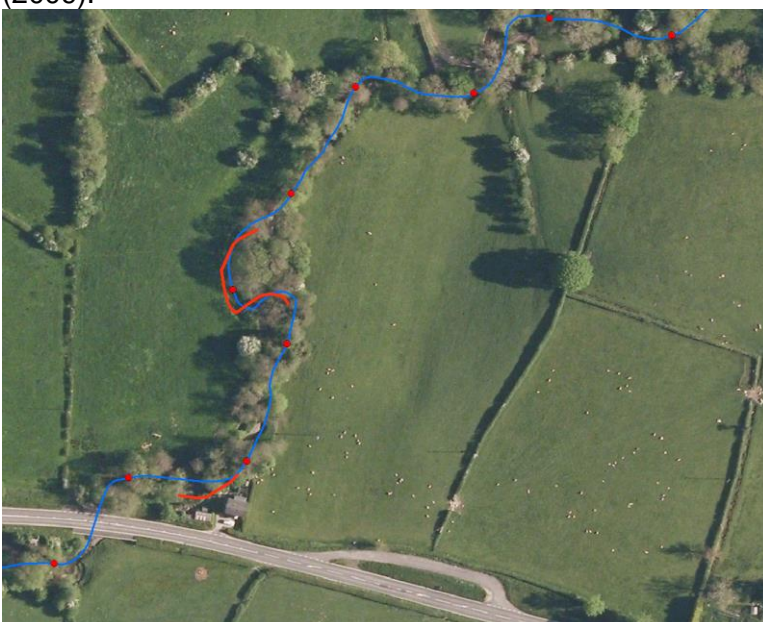
**Figure 4.** A small section of the Mithil Brook with aerial photography, 50m 'spot-check' markers (red circles) and the Fluvial Audit bank protection layer (red lines). Aerial imagery: Infoterrer (2009).

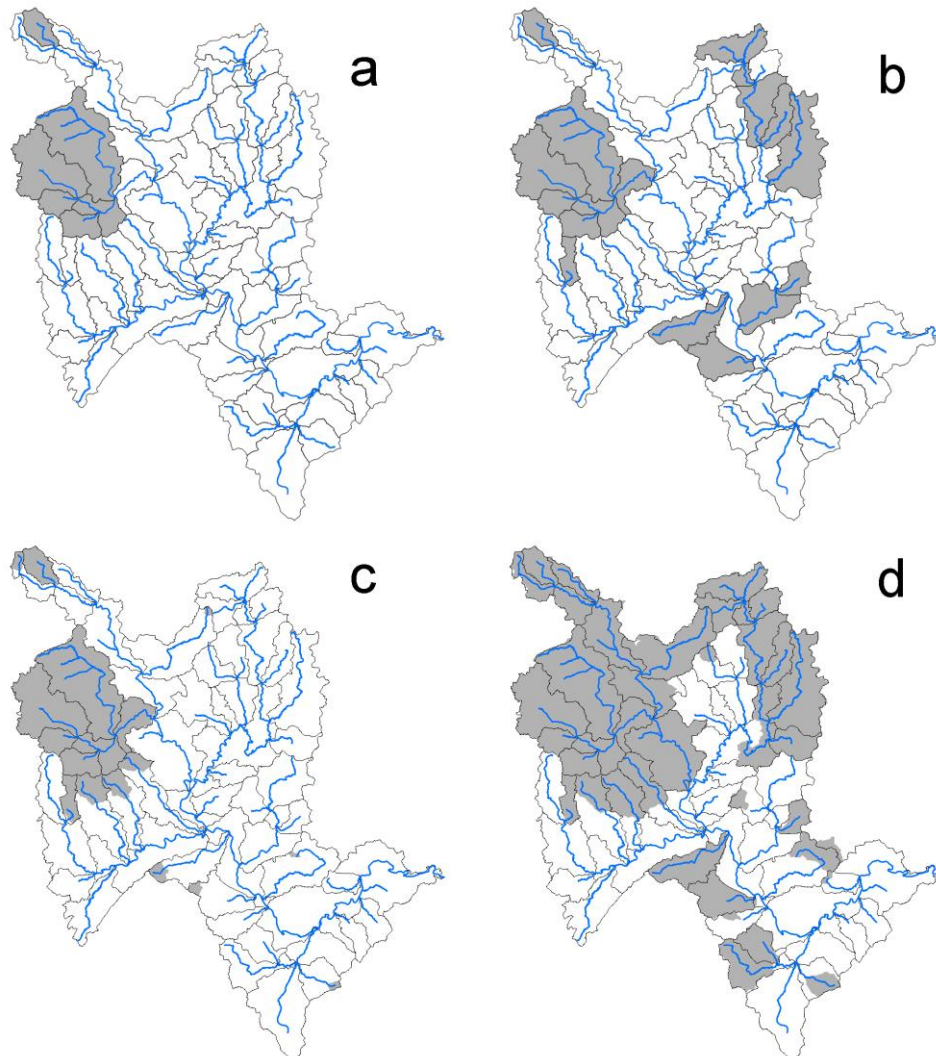
**Figure 6.** Catchments passing the <10% artificial or intensive land cover rule based on LCM2007 (grey shading). The left hand column shows the results of applying the current rule to (a) WFD waterbody catchments and (c) hydrological catchments of each of the 598, 500m reaches, whilst the right hand column illustrates the extreme case of re-classifying all improved grass to a lower intensity (acid/neutral), for the WFD catchments (b) and hydrological catchments (d).
