Newborough Phase 1 Dune Rejuvenation Works Topographic Survey Report

Kenneth Pye & Simon J. Blott

Kenneth Pye Associates Ltd

Report No: 93

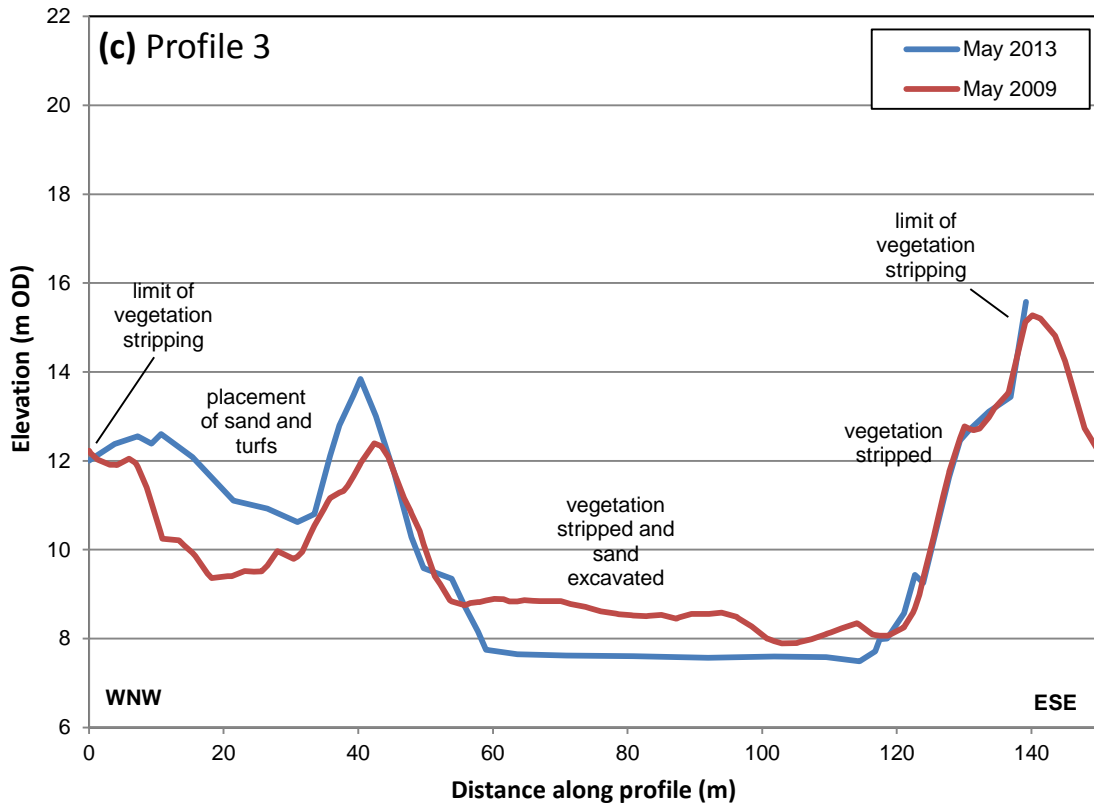
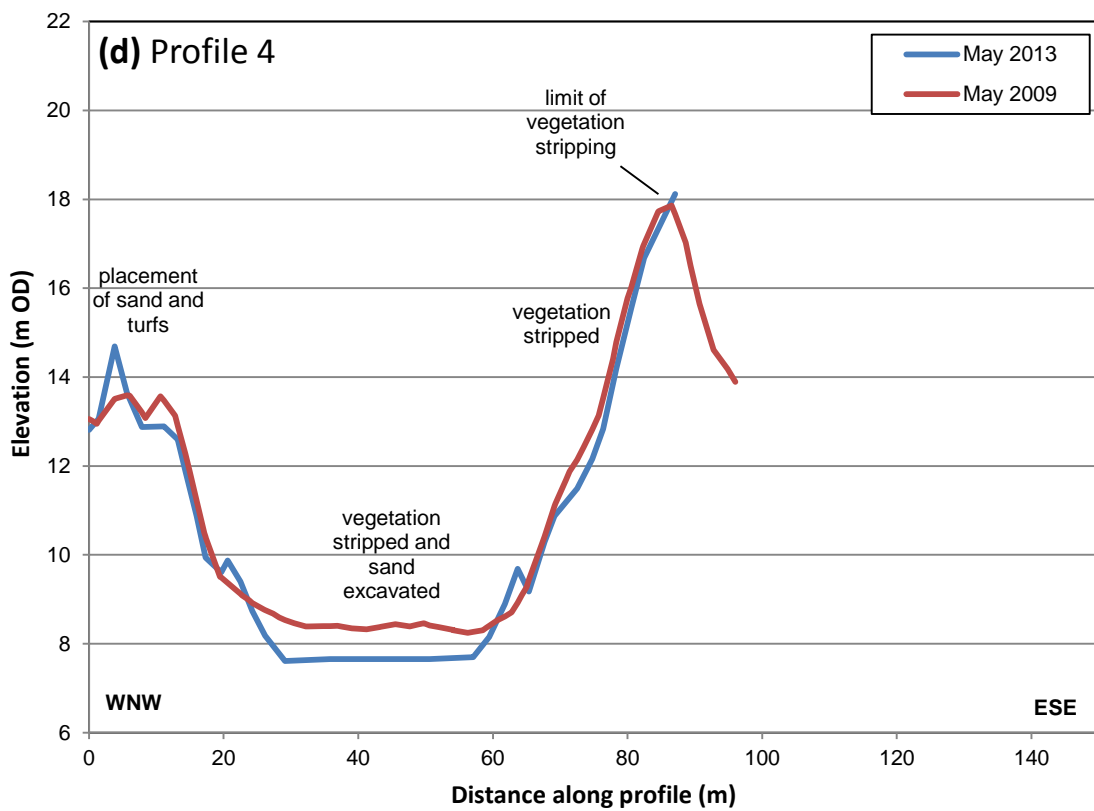
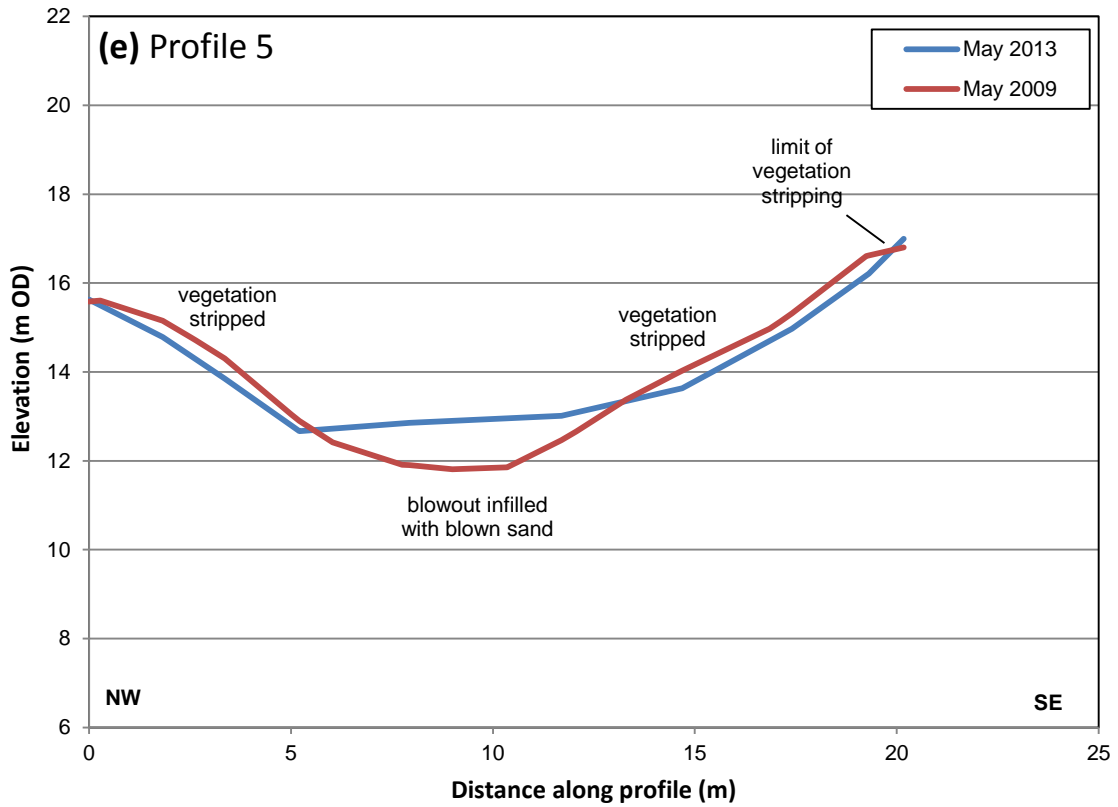
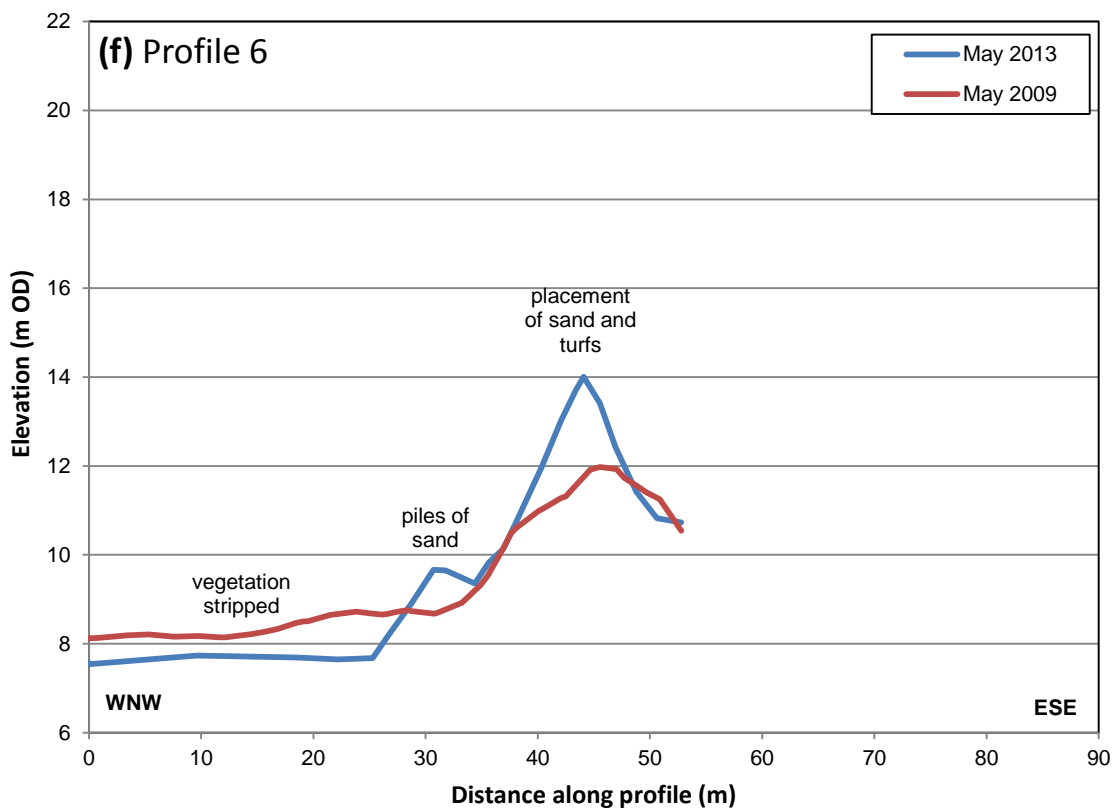
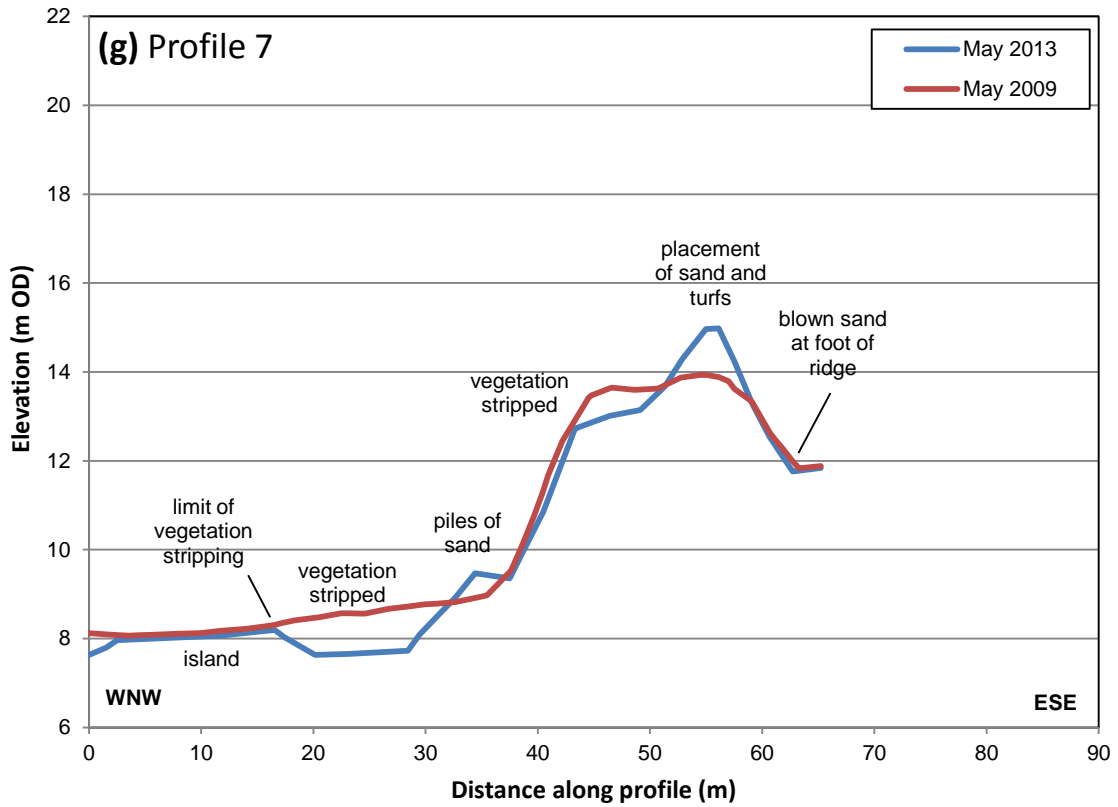
Figure 5. Cross-profiles at Area 2, at the locations indicated in Figure 3, measured from the ground survey on 16 and 17 May 2013, and LiDAR aerial survey in May 2009. Note that the horizontal and linear scales vary considerably.

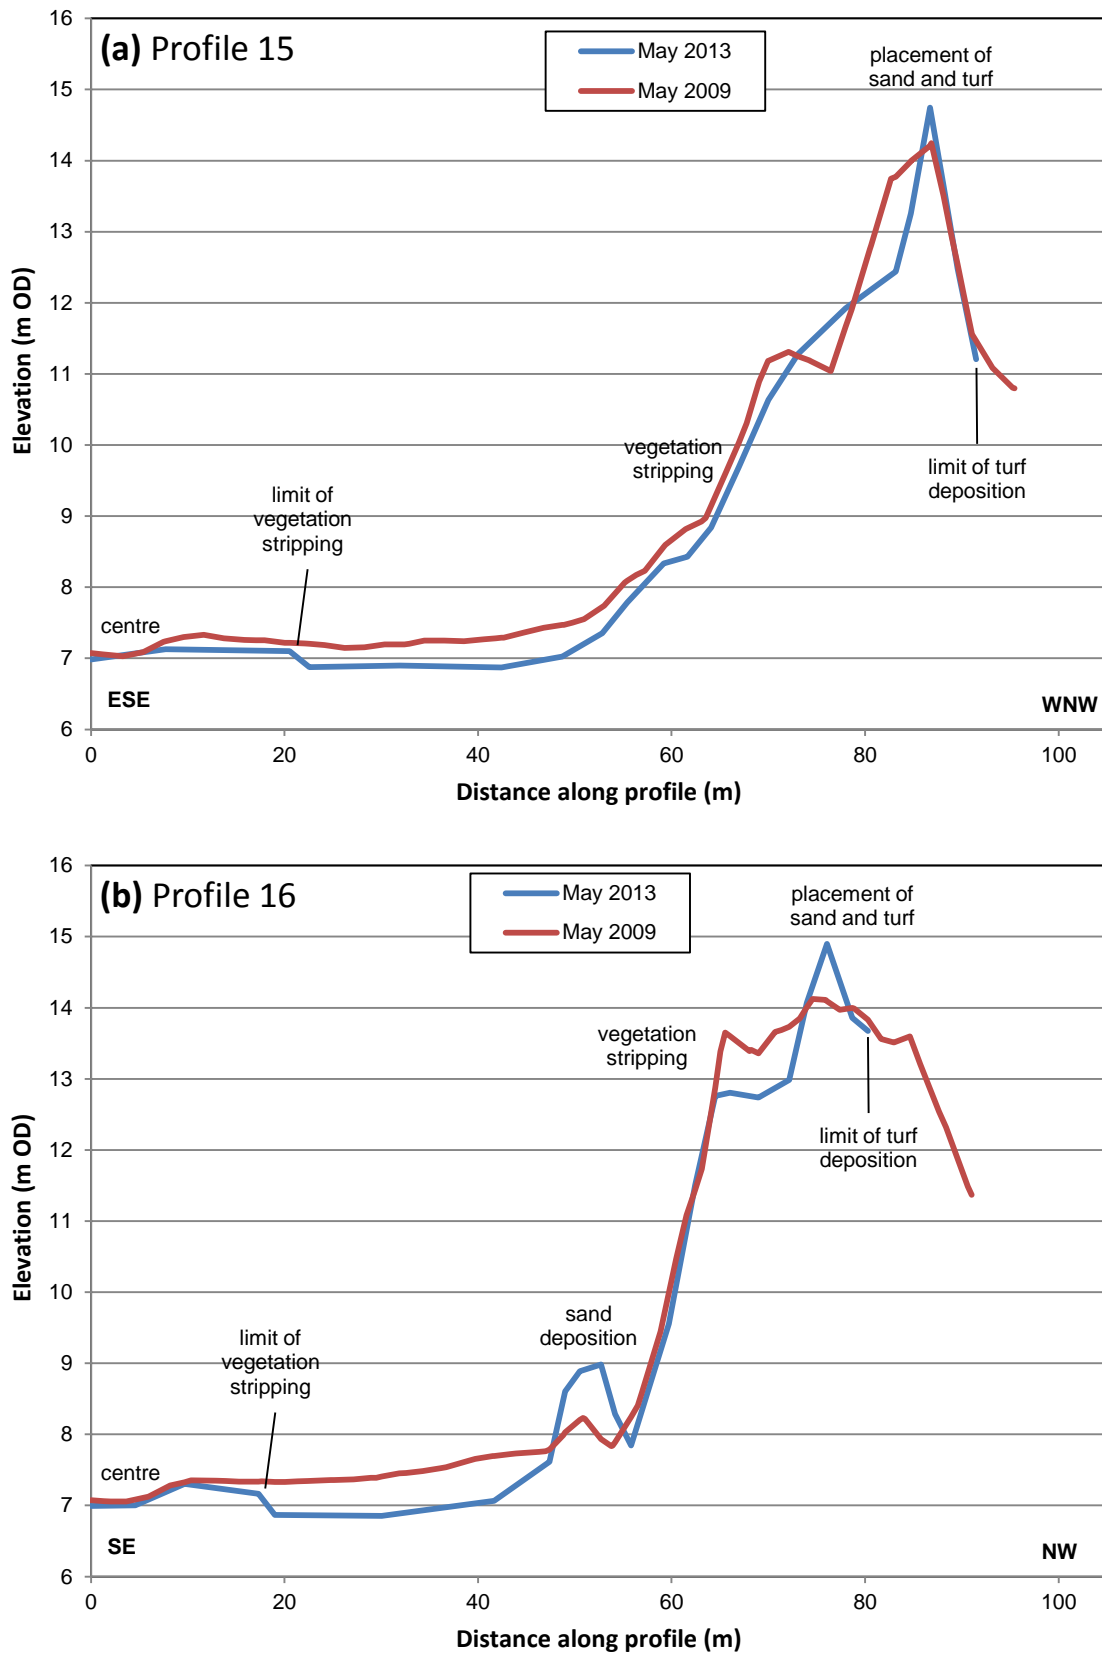
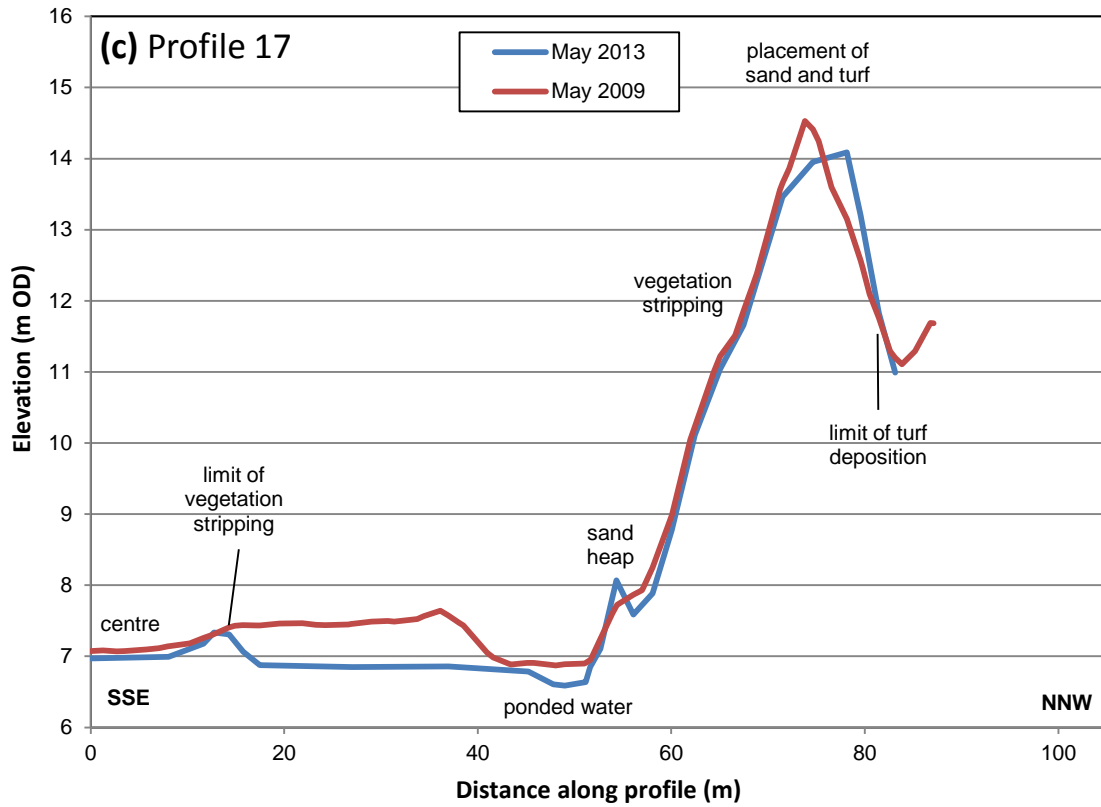
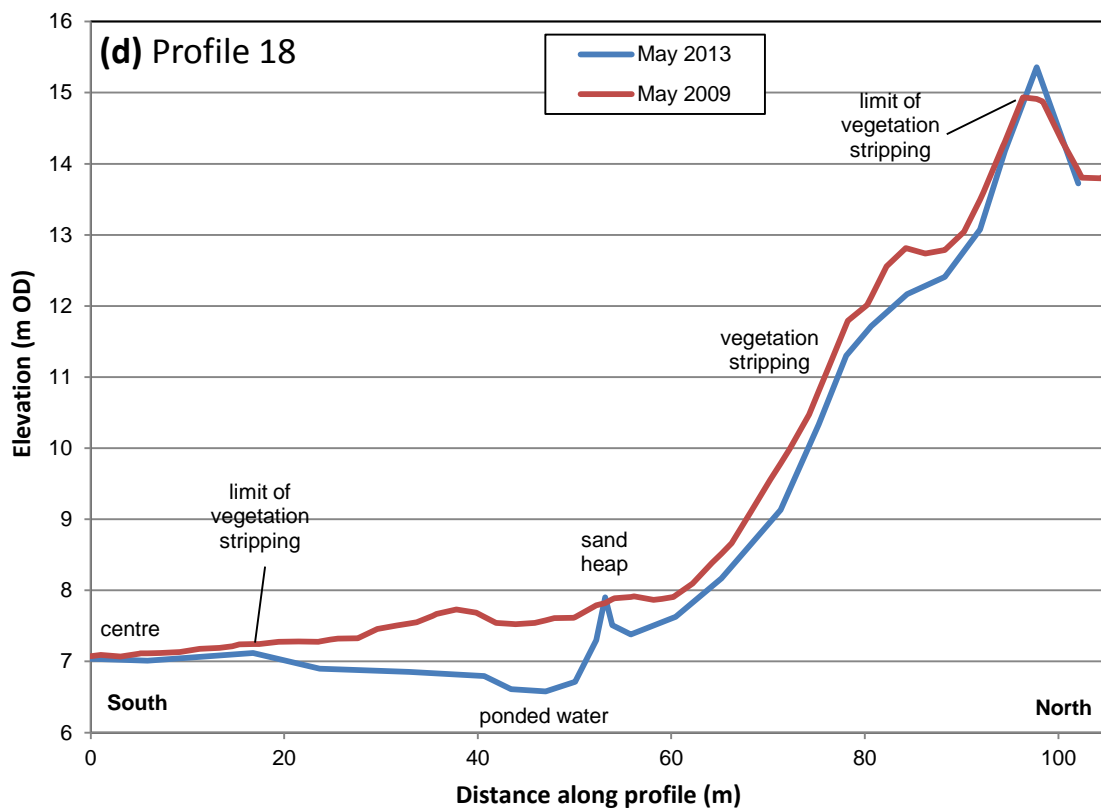
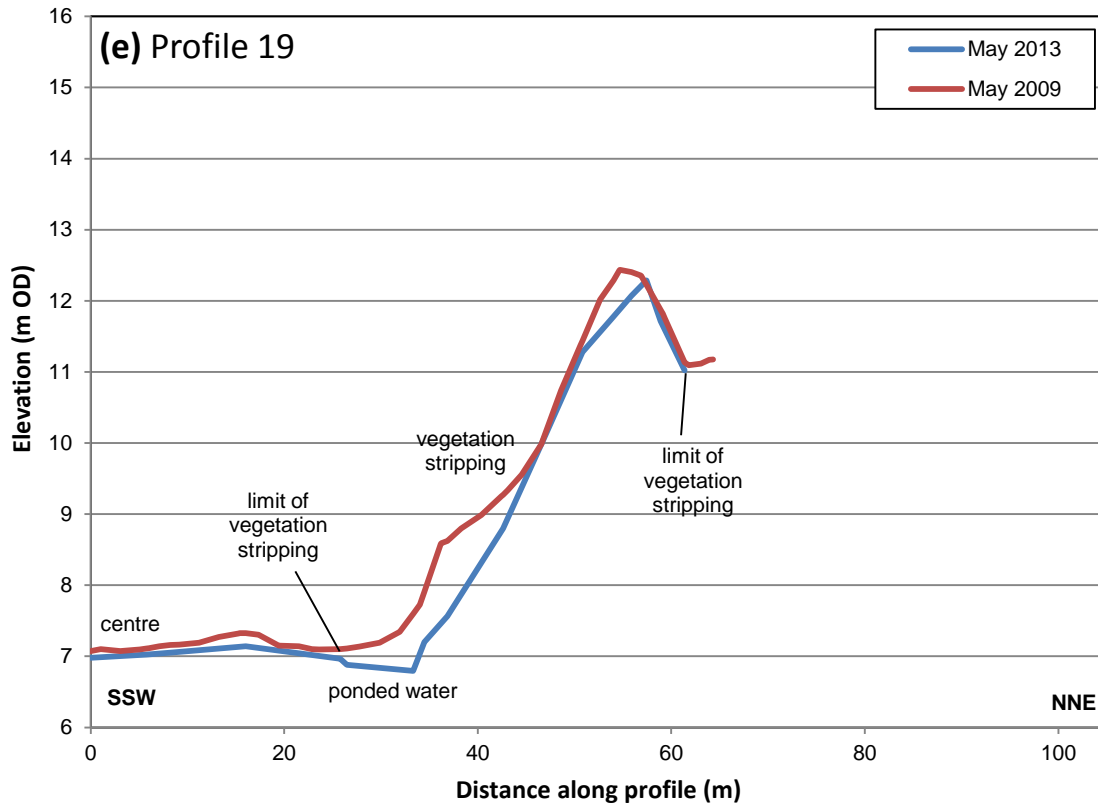
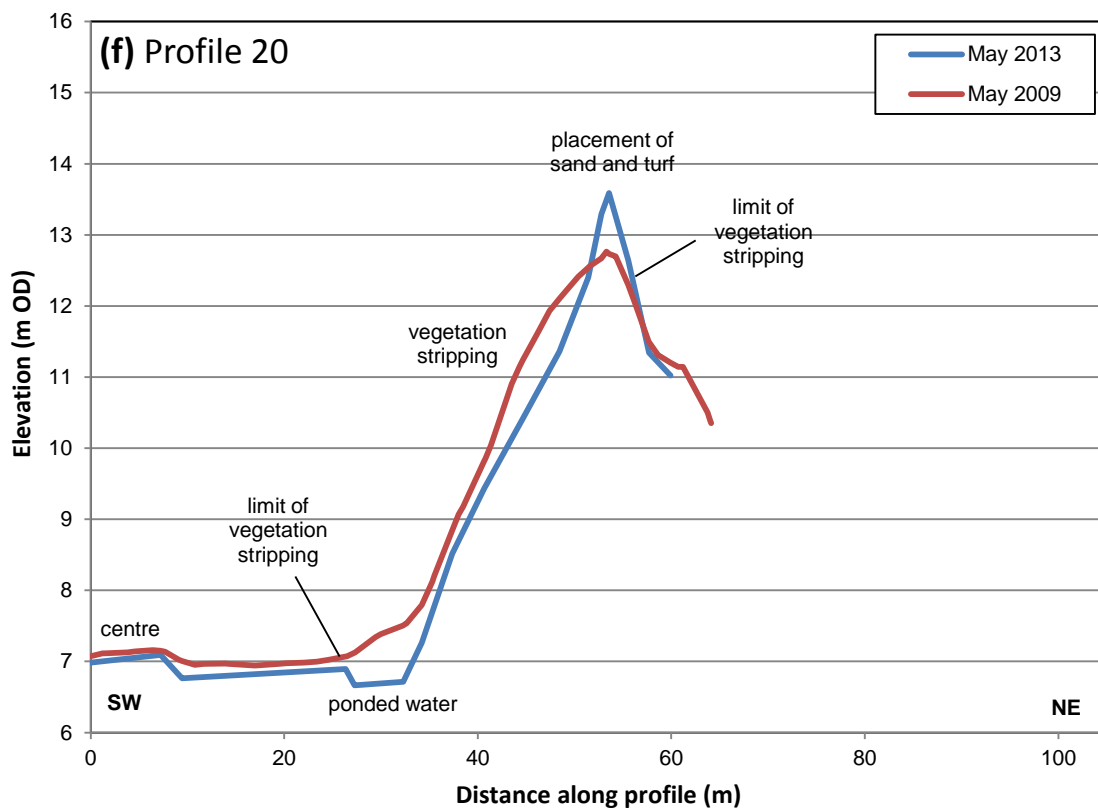
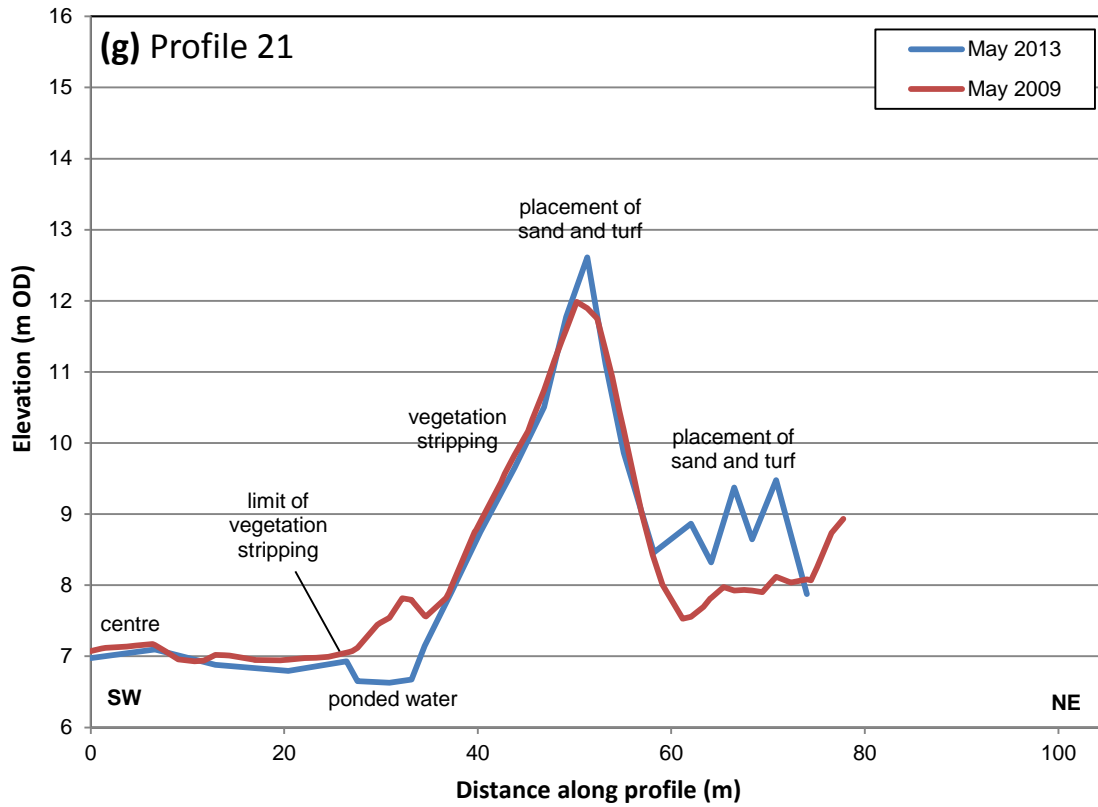
Figure 12. Cross-profiles at Area 3, at the locations indicated in Figure 8, measured from the ground survey on 16 and 17 May 2013, and LiDAR aerial survey in May 2009.

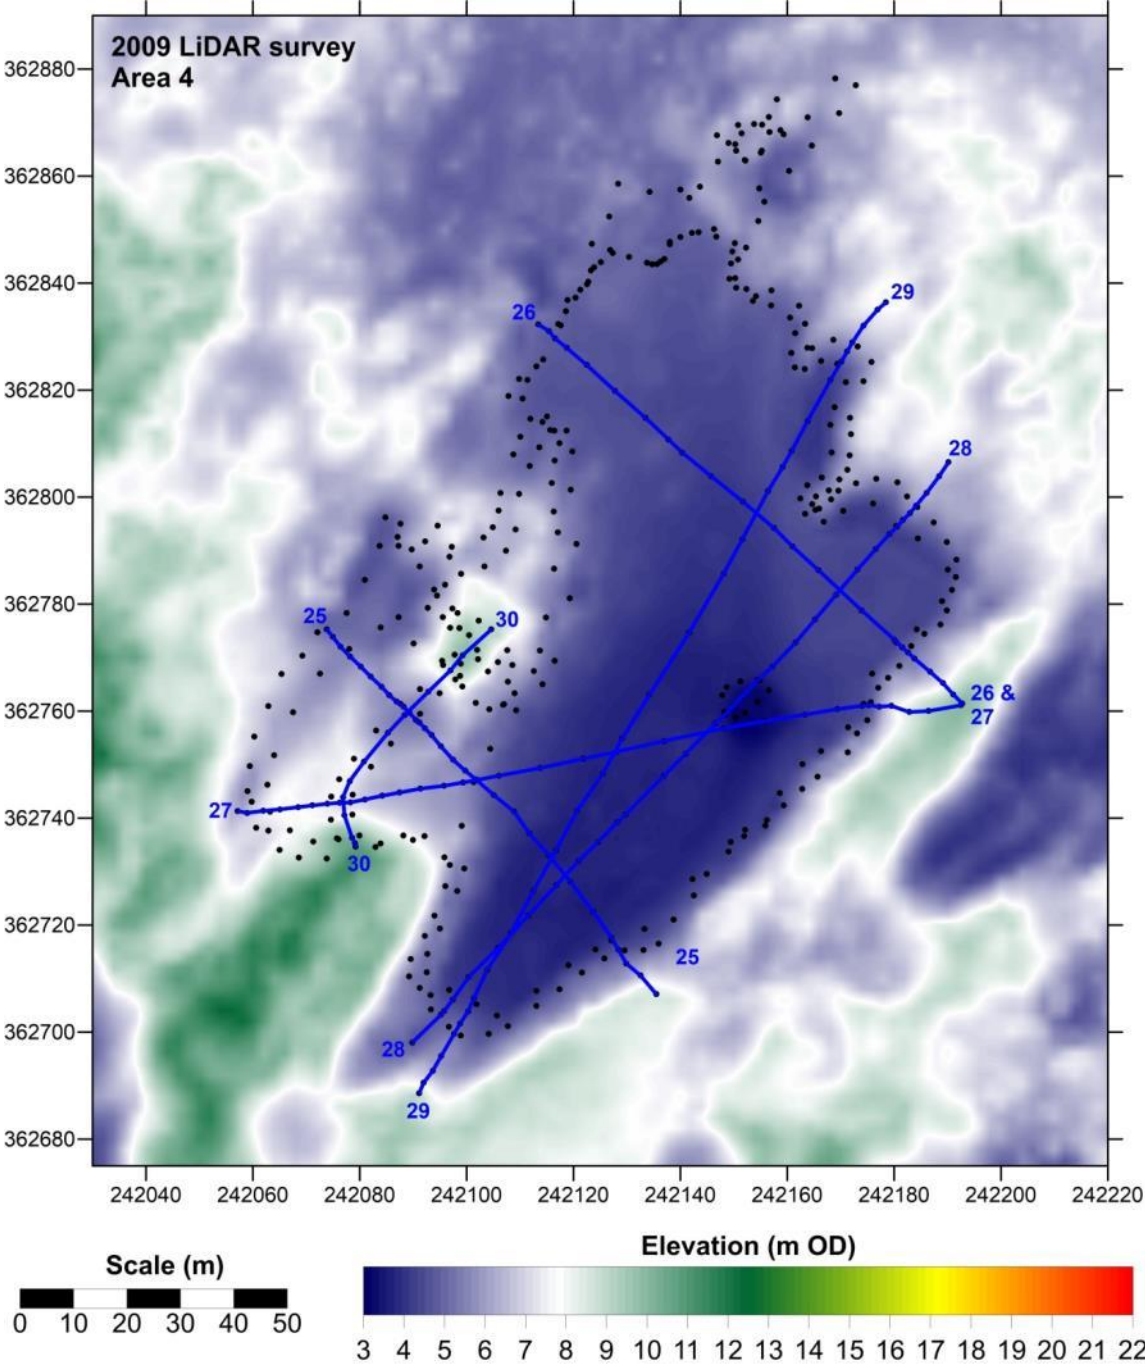
Figure 17. Locations of data points (black dots) and cross-profiles (blue lines), overlaid on 2009 LiDAR DEM, in Area 3

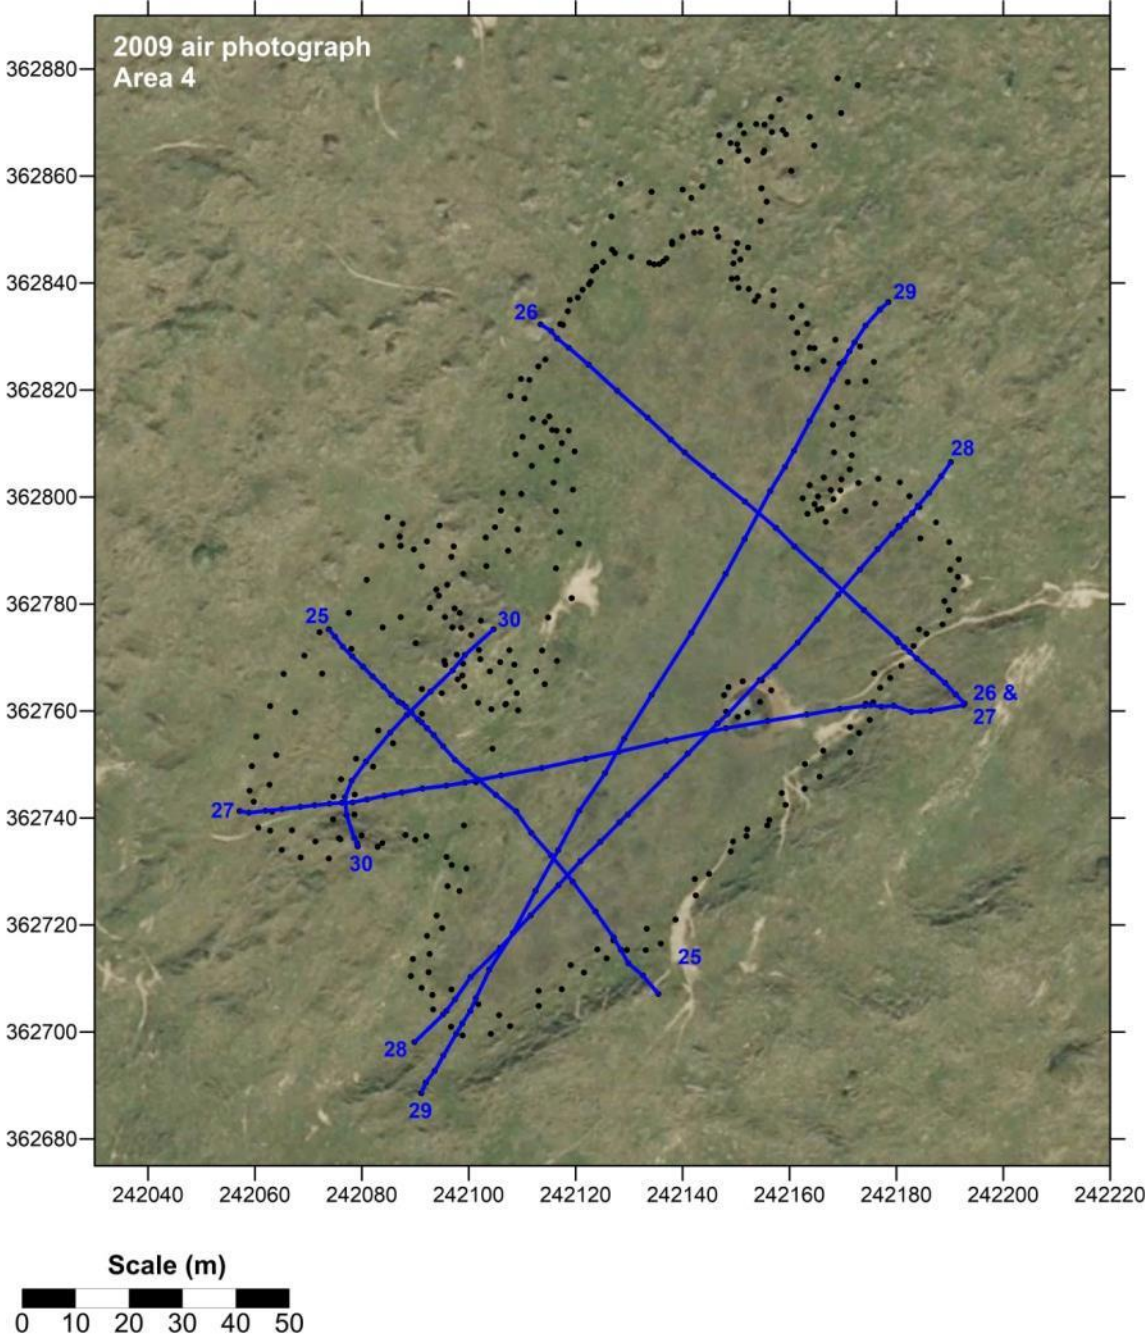
Figure 18. Locations of data points (black dots) and cross-profiles (blue lines), overlaid on 2009 air photographs, in Area 3

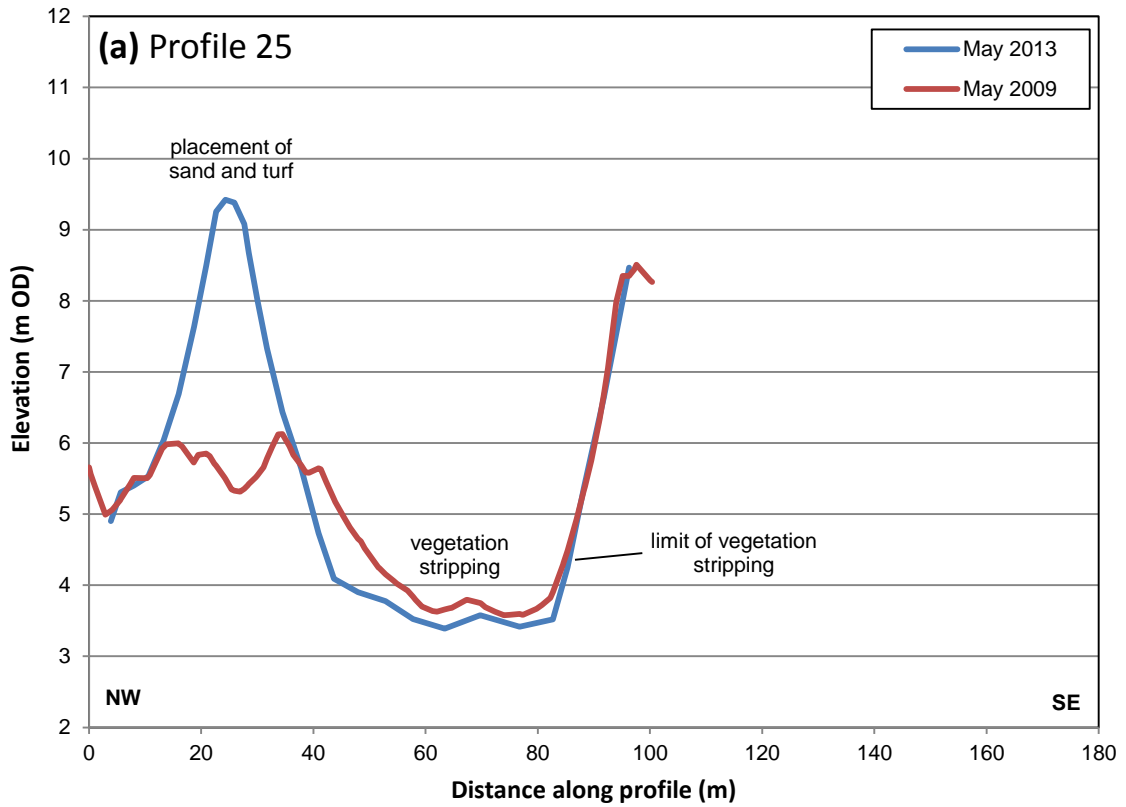
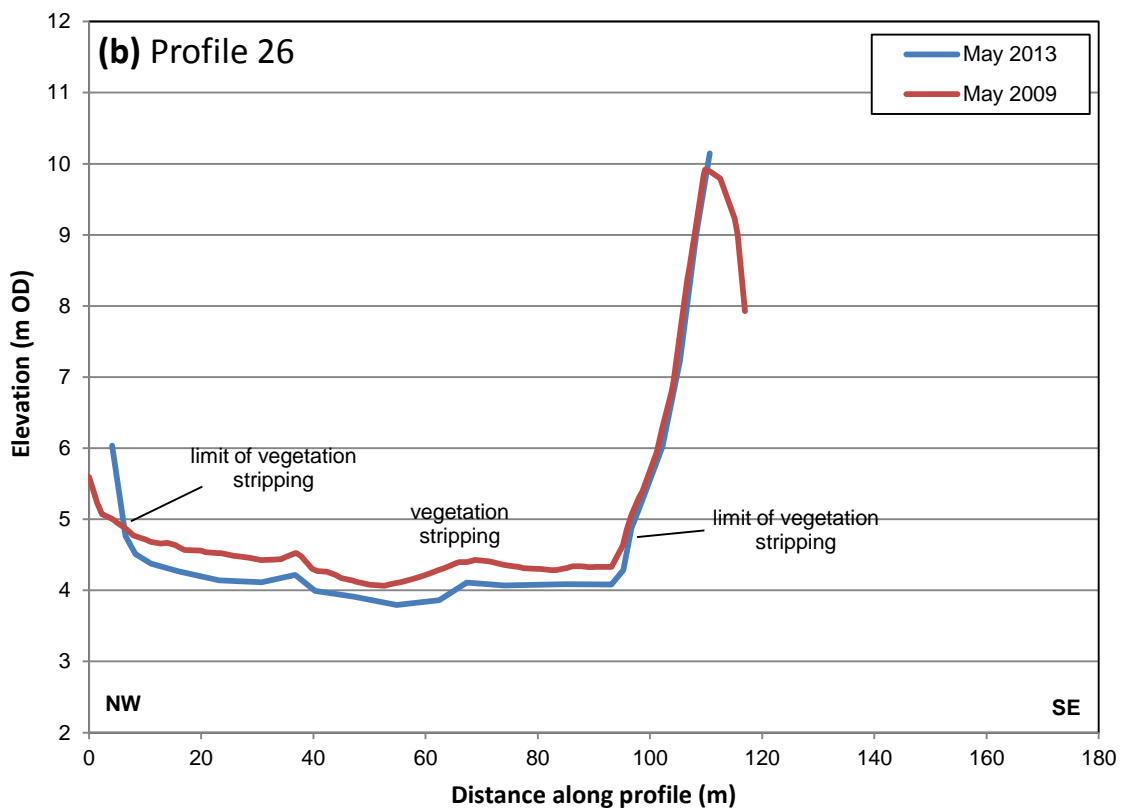
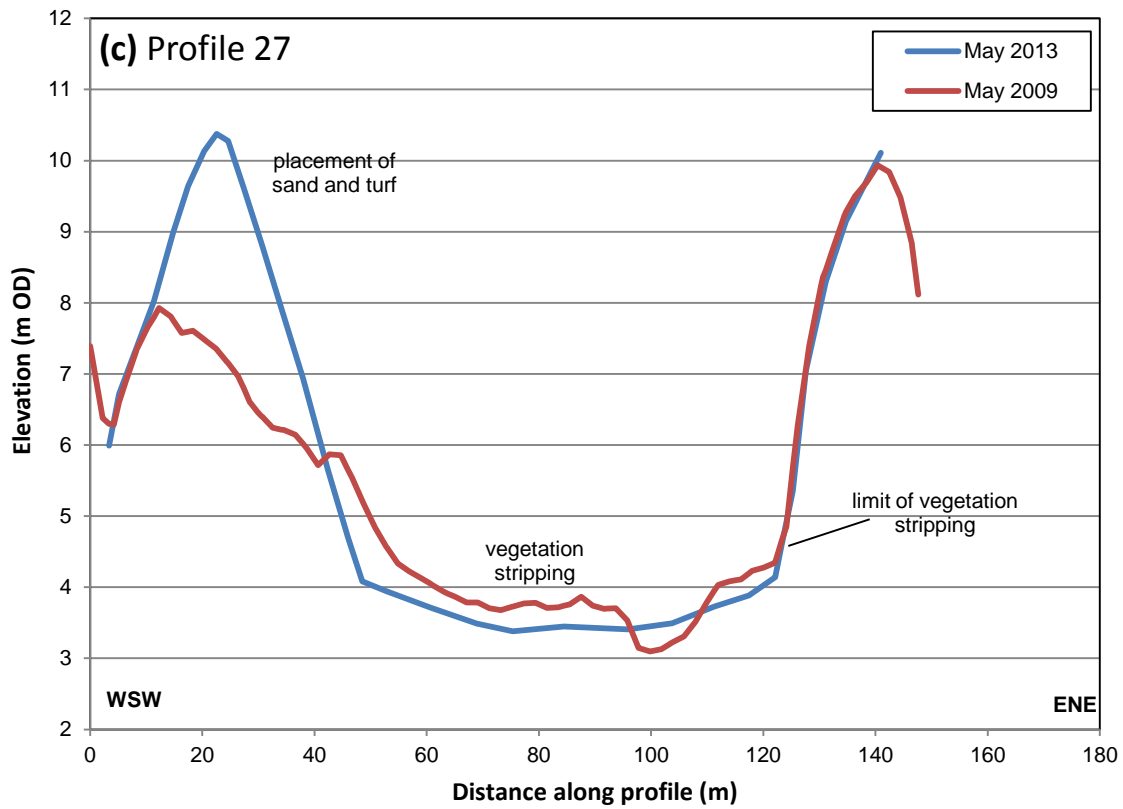
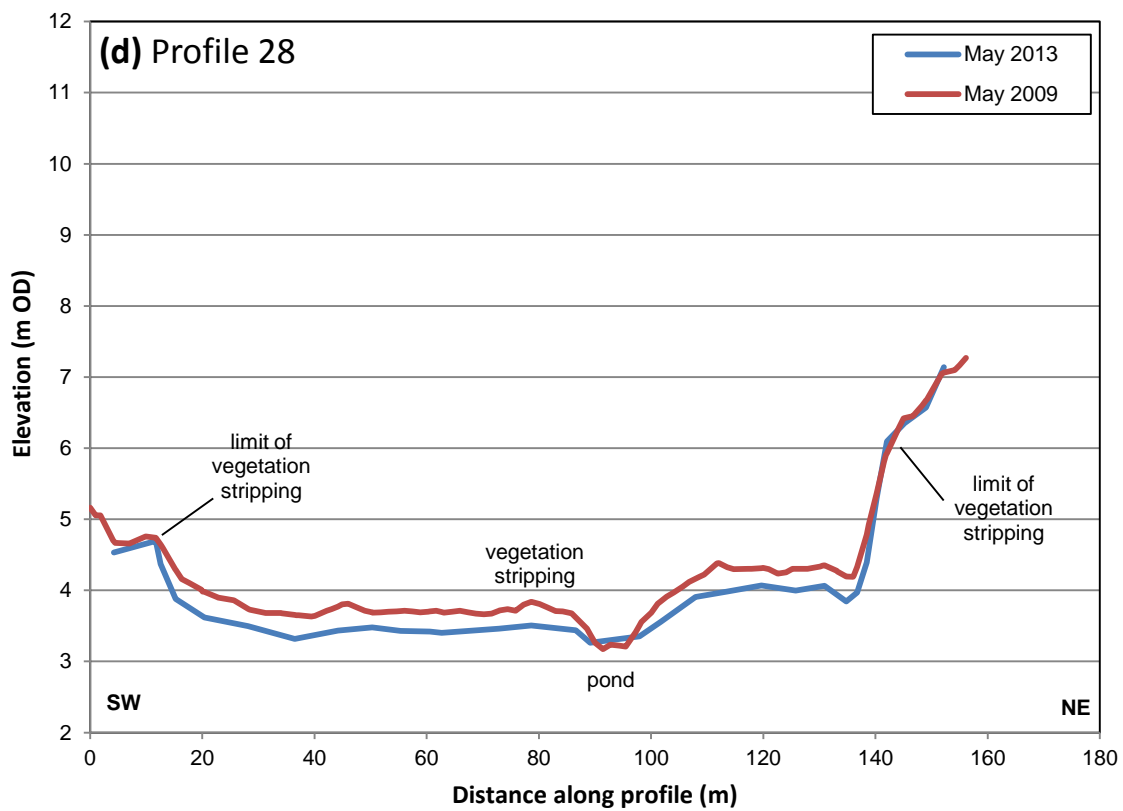
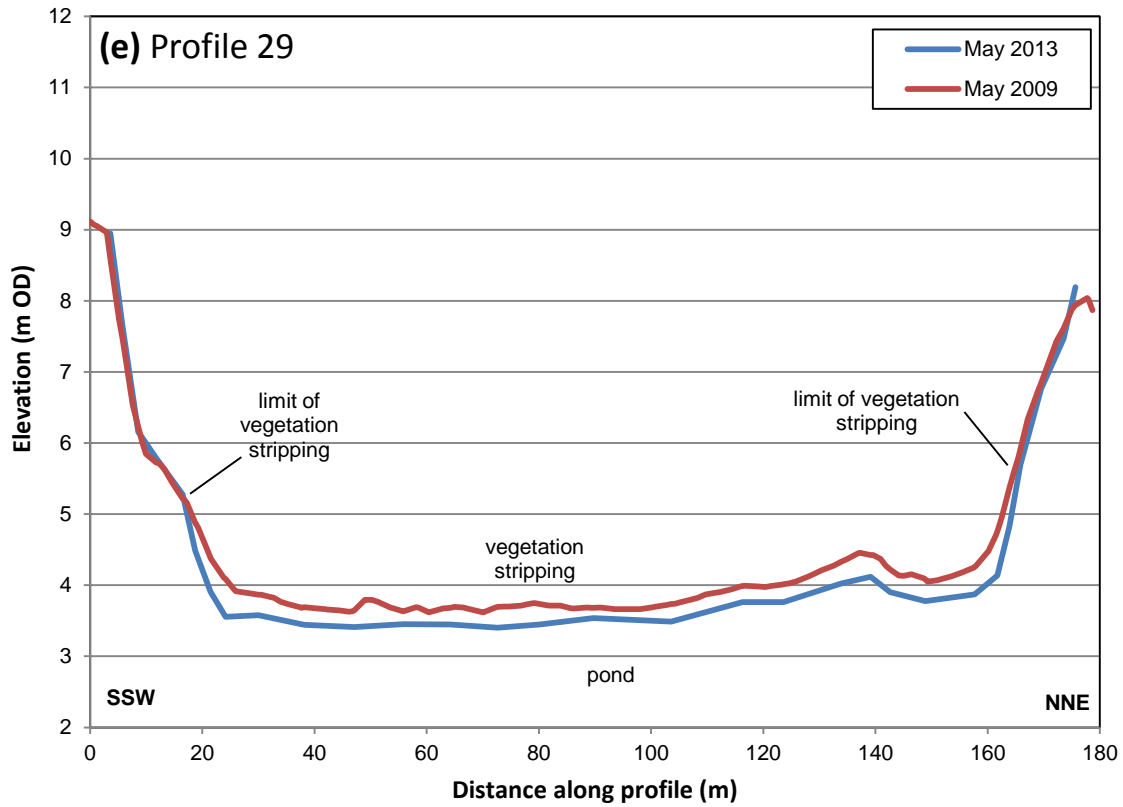
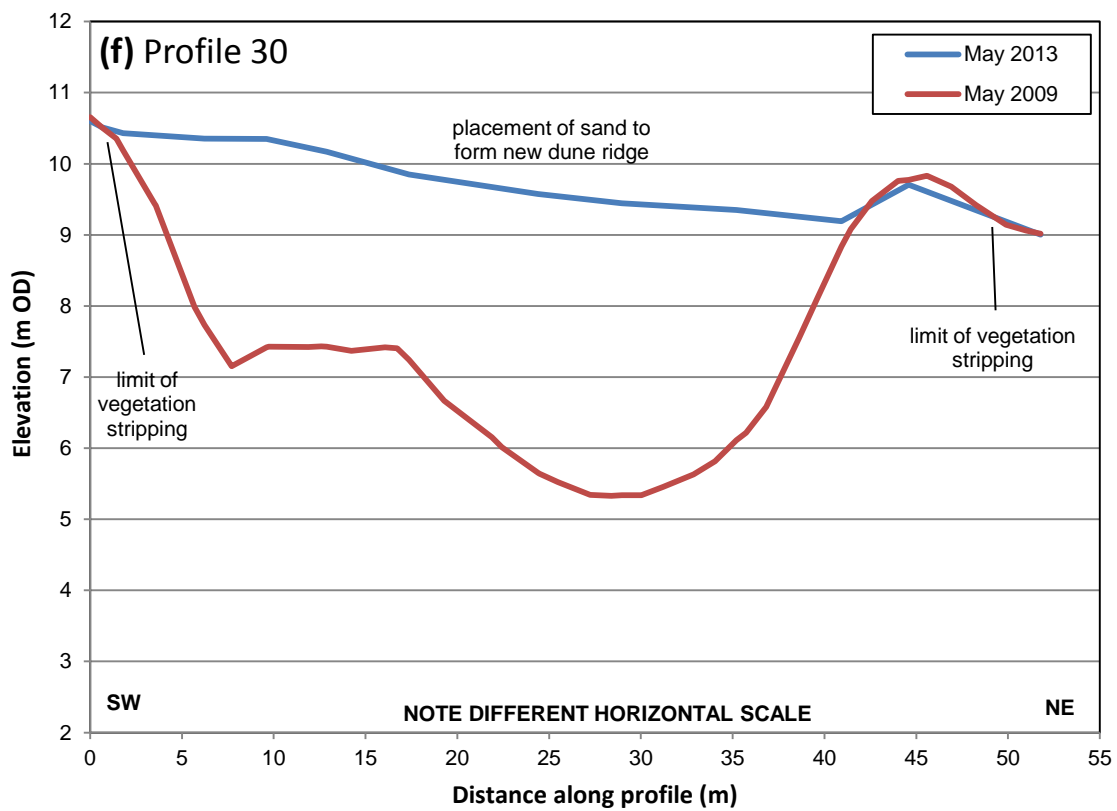
Figure 19. Cross-profiles at Area 4, at the locations indicated in Figure 13, measured from the ground survey on 16 and 17 May 2013, and LiDAR aerial survey in May 2009.

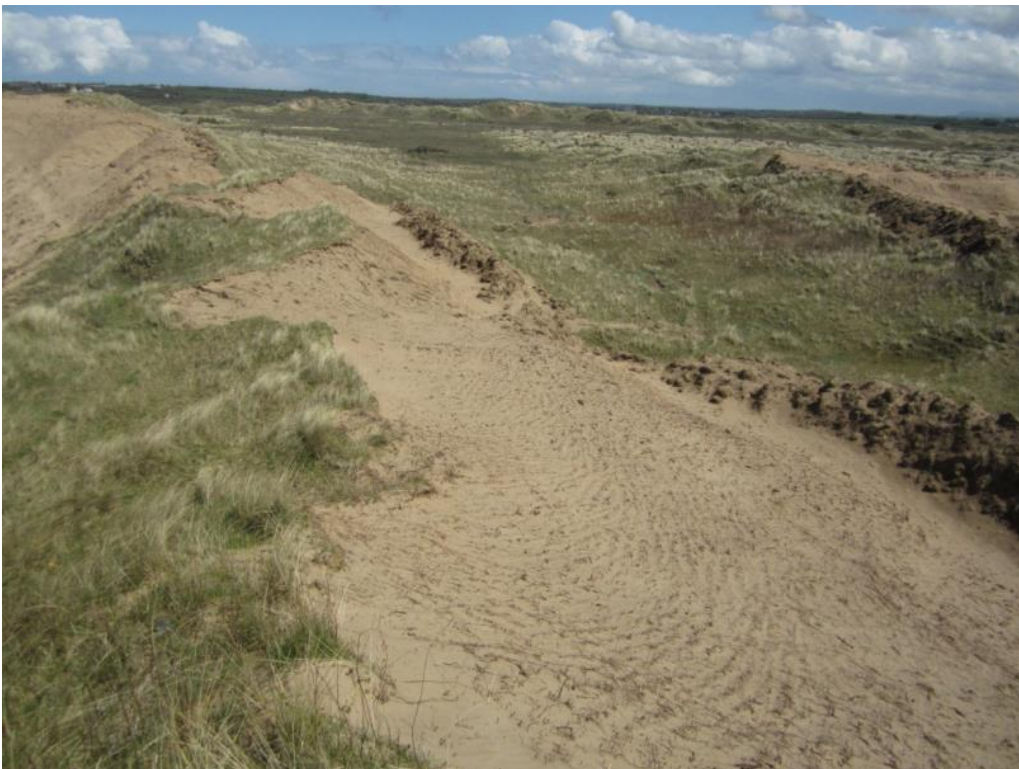
Photo 4. Area 2, looking NE from Benchmark 1. Vegetation stripping on the eastern side of the ridge can be seen in the foreground.

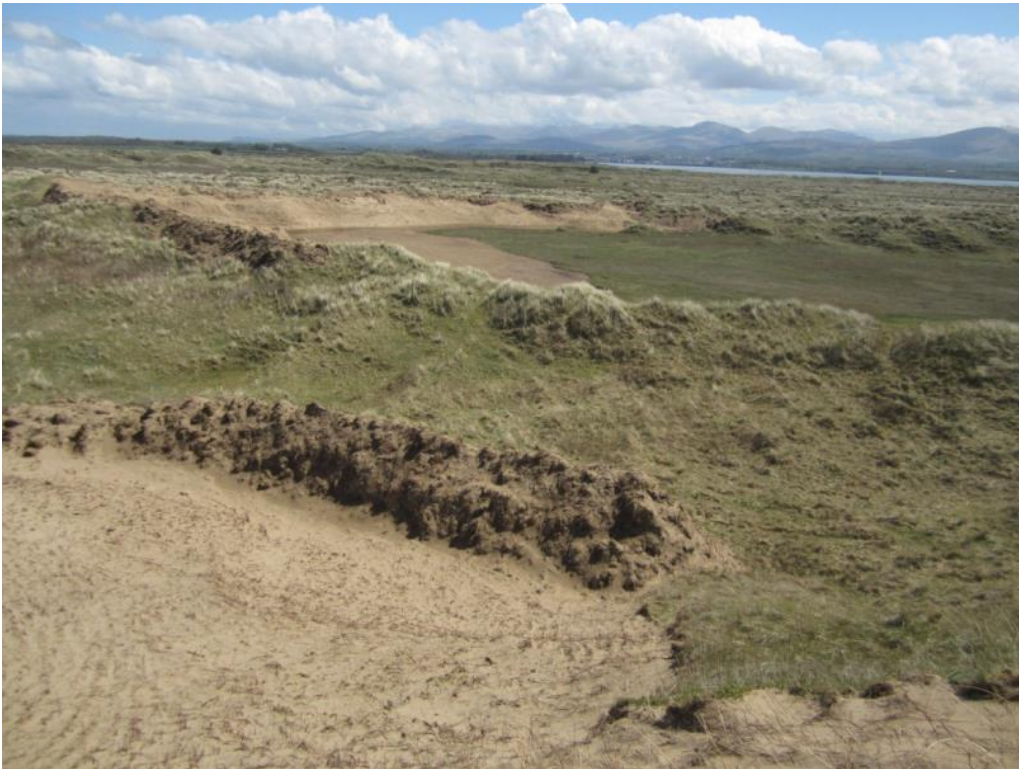
Photo 5. Area 2, looking W from Benchmark 1. Pile of sand and turf in the foreground, Area 3 in the background.

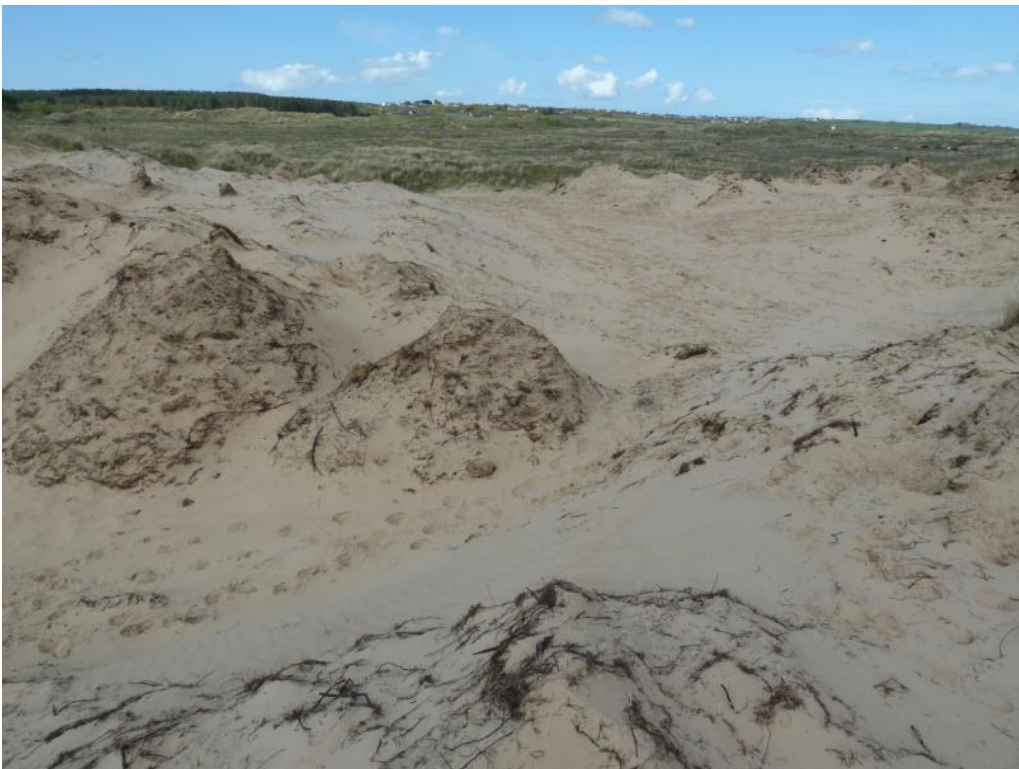
Photo 6. Area 2, north-western part of the site. Piles of turf in the foreground, vehicle access tracks in the centre.

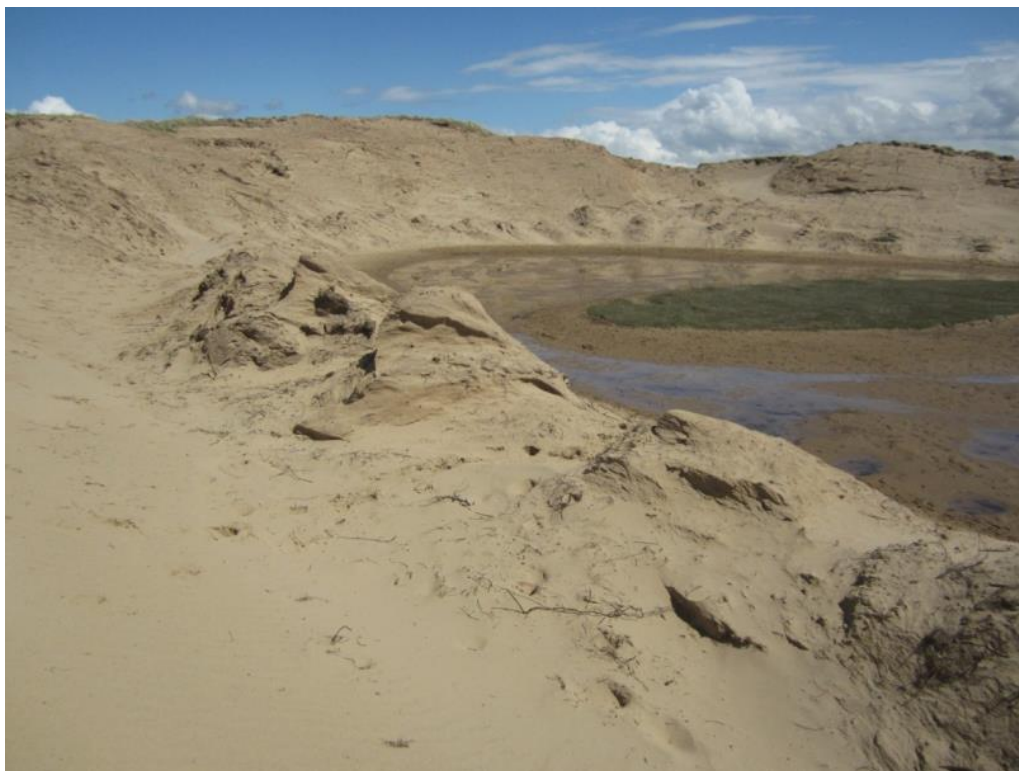
Photo 7. Area 2, showing sacrificial heaps of sand placed around the base of the dune.
