Newborough Phase 1 Dune Rejuvenation Works Topographic Survey Report

Kenneth Pye & Simon J. Blott

Kenneth Pye Associates Ltd

Report No: 93

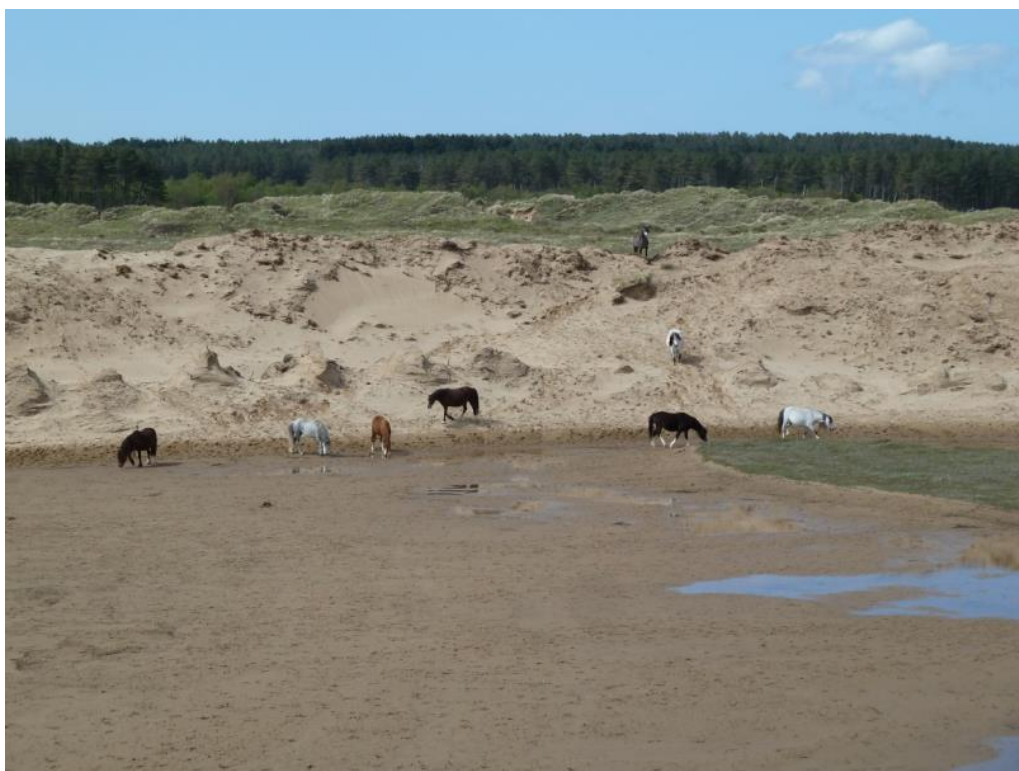
Photo 8. Area 2, looking NW across the site. Surface disturbance by ponies is important at this site.

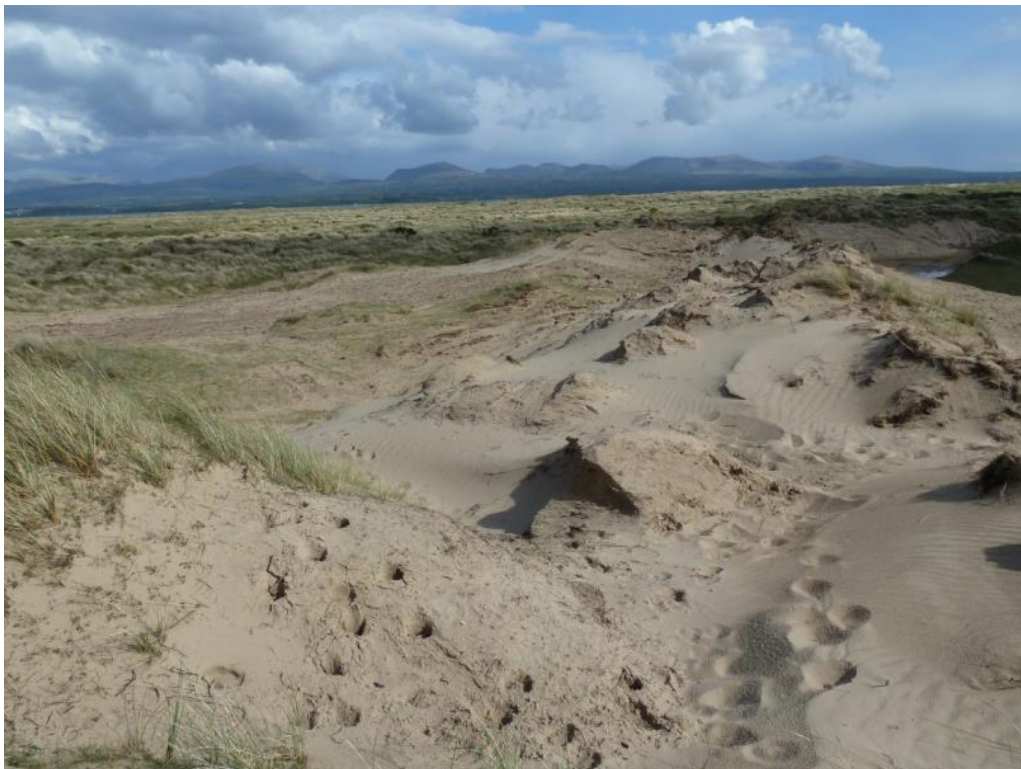
Photo 10. Area 3, showing vegetation stripping and deposition of turfs to the rear of the dune head.

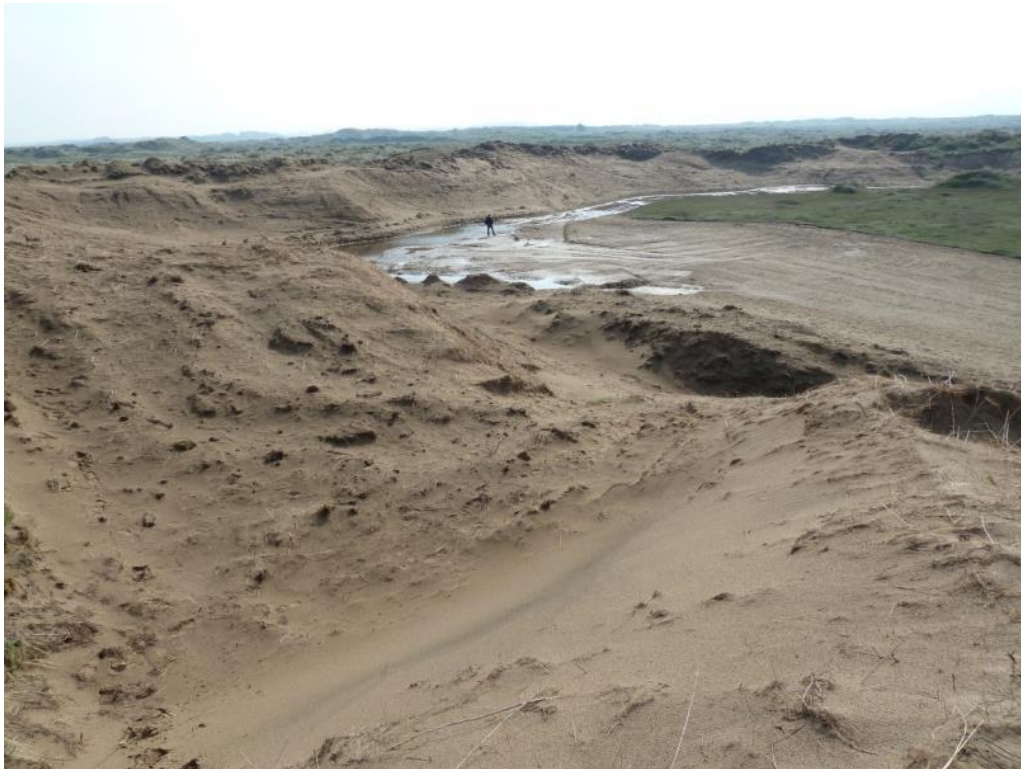
Photo 11. Area 3, looking east from the western arm of the dune, showing transverse ridge crest in the foreground.

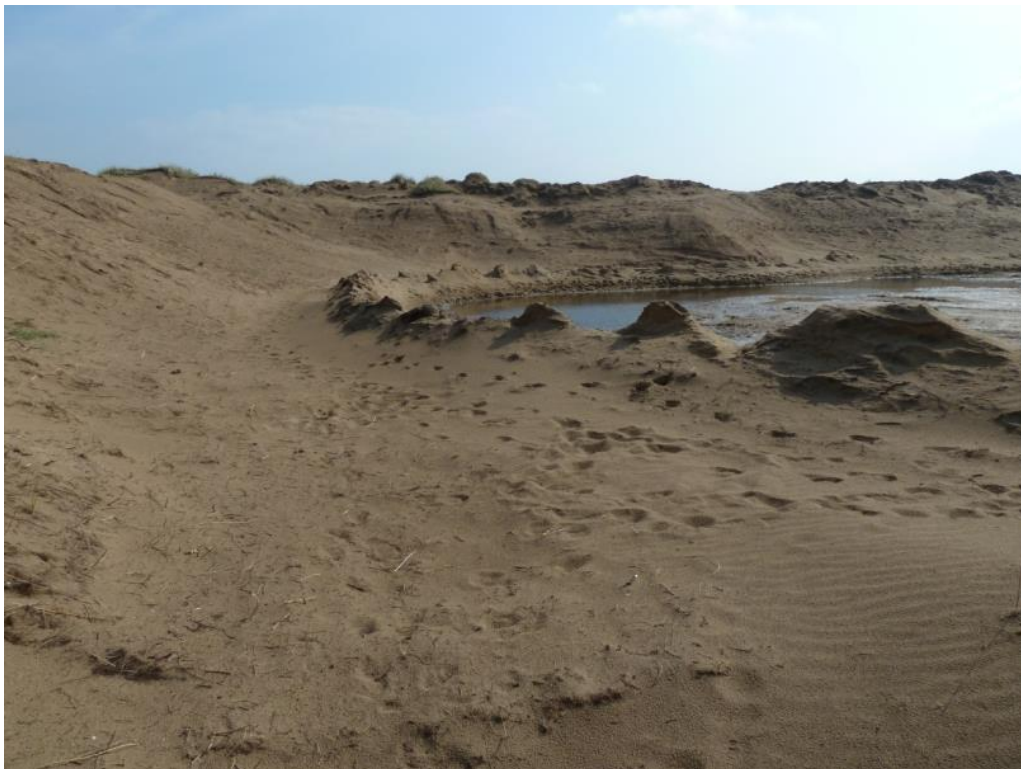
Photo 12. Area 3, showing sacrificial heaps of sand placed around the base of the dune.

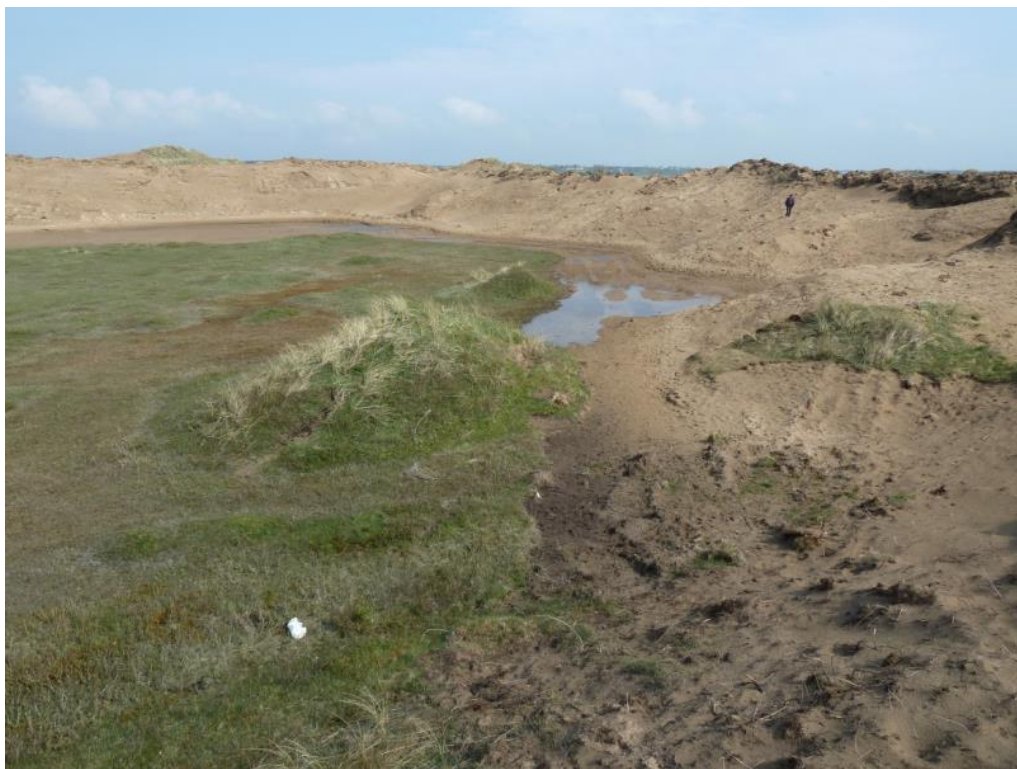
Photo 13. Area 3, showing the SE part of the site, two nebkha dunes in the foreground.

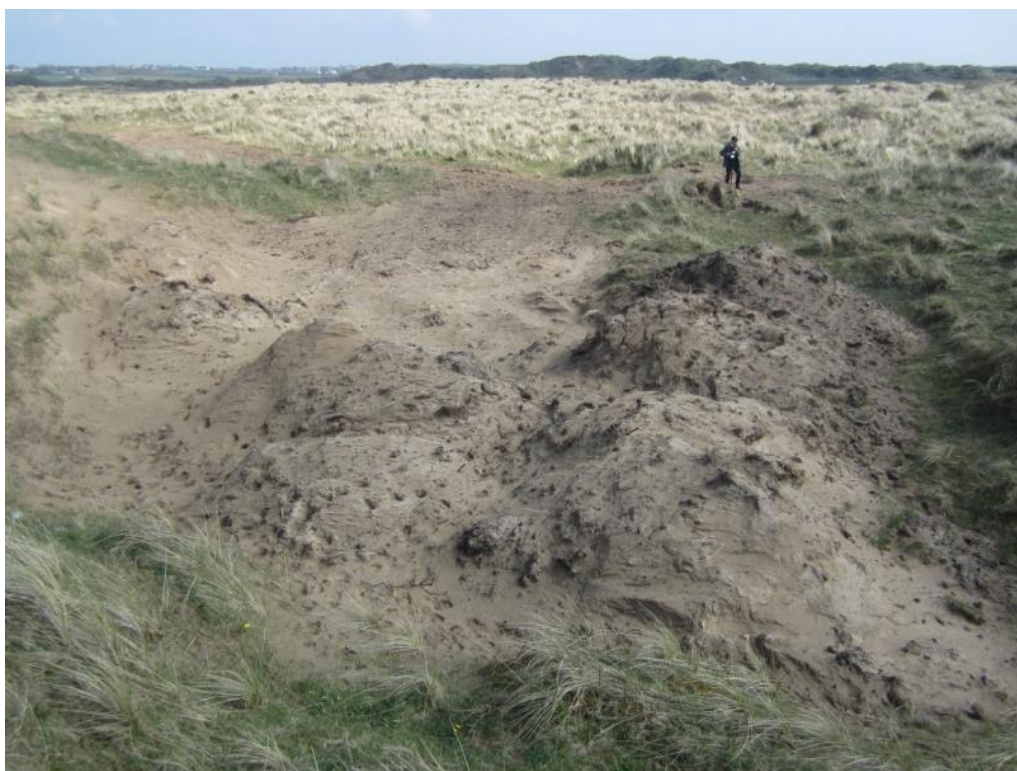
Photo 14. Area 3, piles of sand and turf to the rear of the dune head.

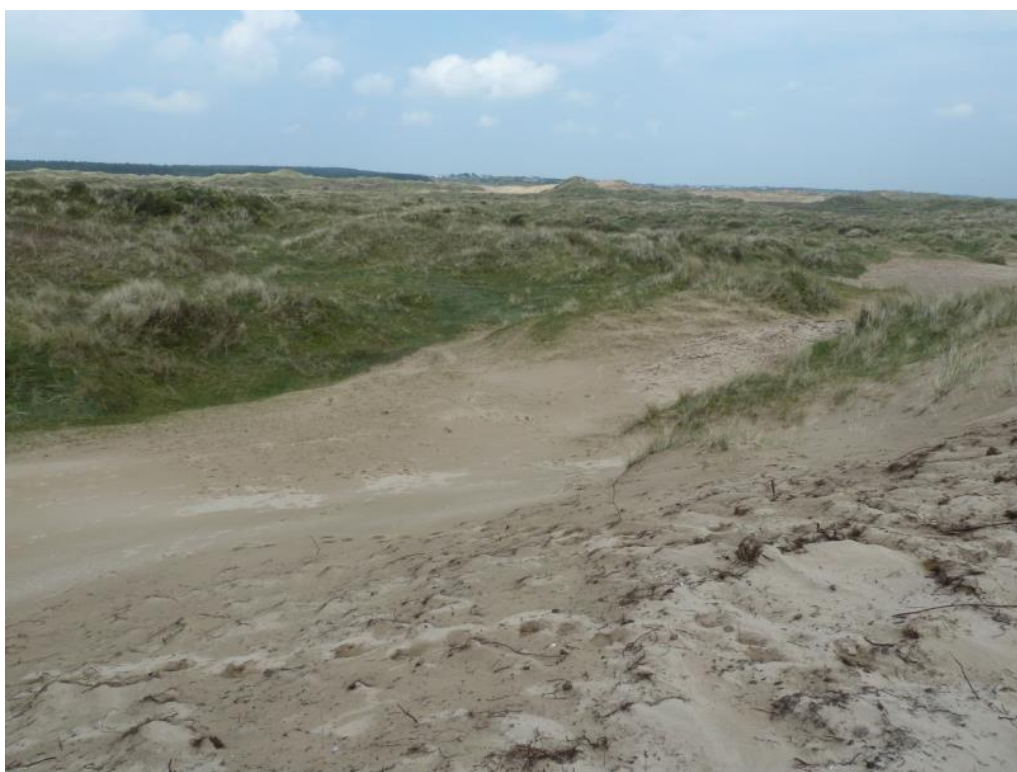
Photo 16. Area 3, vegetation stripping and blown sand areas to the north and west of the newly constructed dune ridge

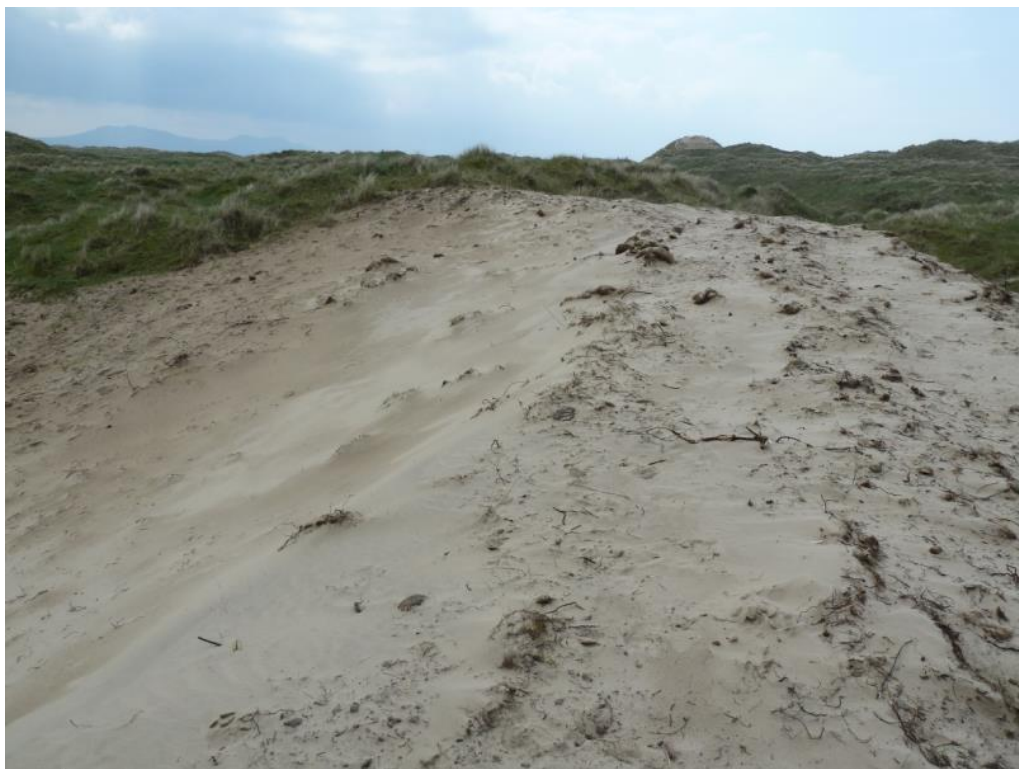
Photo 17. Area 3, looking SW along the crest of the new dune ridge.
