Intertidal SAC monitoring of *Zostera marina* at Porth Dinllaen, Pen Llŷn a’r Sarnau SAC 2016

NRW Evidence Report No: 064

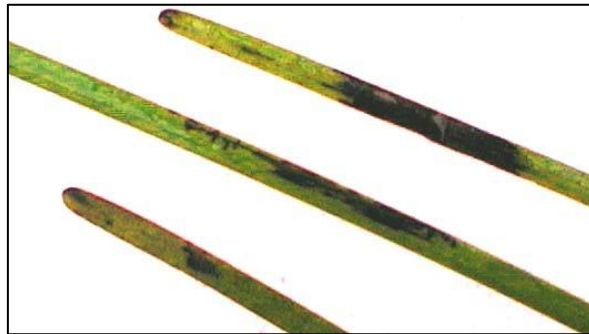
Figure 1 Infected plant with spots, large blackened region and streaking caused by the wasting disease (Ralph & Short 2002)

During the 1930's *Zostera marina* populations were significantly reduced due to the 'wasting disease', a pathogenic marine slime mould *Labyrinthula zosterae*. During this epidemic, an estimated 90% of *Z. marina* in the north Atlantic was lost (Bull *et al.* 2010). Wasting disease is still present in *Z. marina* beds but not at the scale of the 1930s epidemic (Bull *et al.* 2010). Increased stress due to higher summer temperatures is believed to have led to the outbreak of the 'wasting disease' during the 1930's (Muehlstein *et al.* 1991; Bull *et al.* 2010). 'Wasting disease' can be spread directly from plant to plant either by being in direct contact with an infected plant or via an infected drift plant (Ralph & Short 2002). Symptoms of the 'wasting disease' are the initial presence of black-brown

dots which then lead to larger blacker spots and streaks (Figure 1) then finally the plant dies (Ralph & Short 2002).

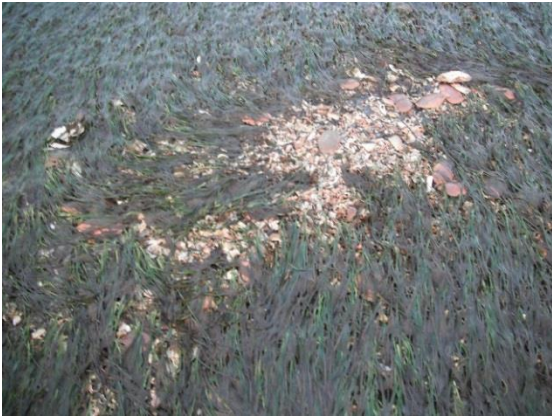
Figure 6 Discard of crab shells smothering parts of the seagrass (20160919 LK Porth Dinllaen 2283)

survey an additional impact of discarded crab shells was noted which was confined to a few small discrete areas, therefore having a smothering effect on the plants. See Appendix 4 for the data on damage.

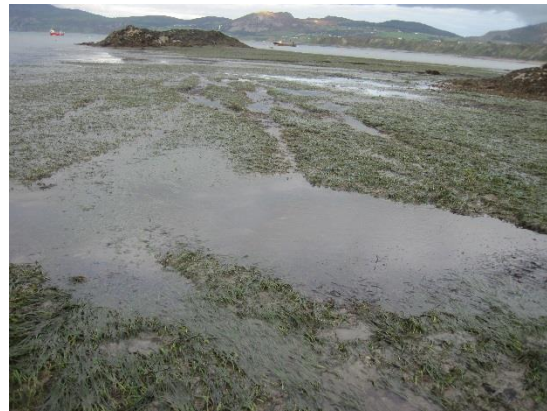
Figure 7 Tyre tracks observed over the seagrass, creating deep depressions (20160919 NL Porth Dinllaen 0475)

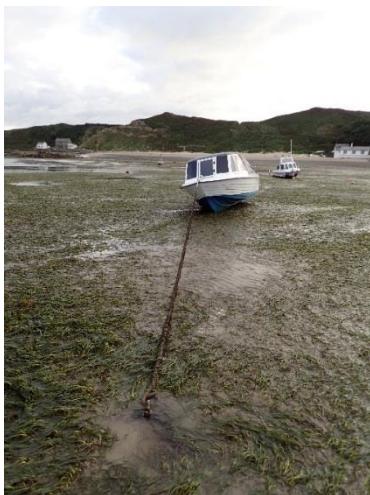
Figure 8 Mooring that consists mainly of rope (20160919 BW Porth Dinllaen 0041)

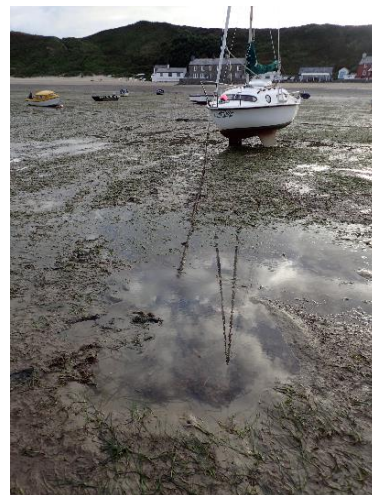
Figure 9 Pooling effect in the seagrass caused by a mooring chain (20160919 BW Porth Dinllaen 0044)

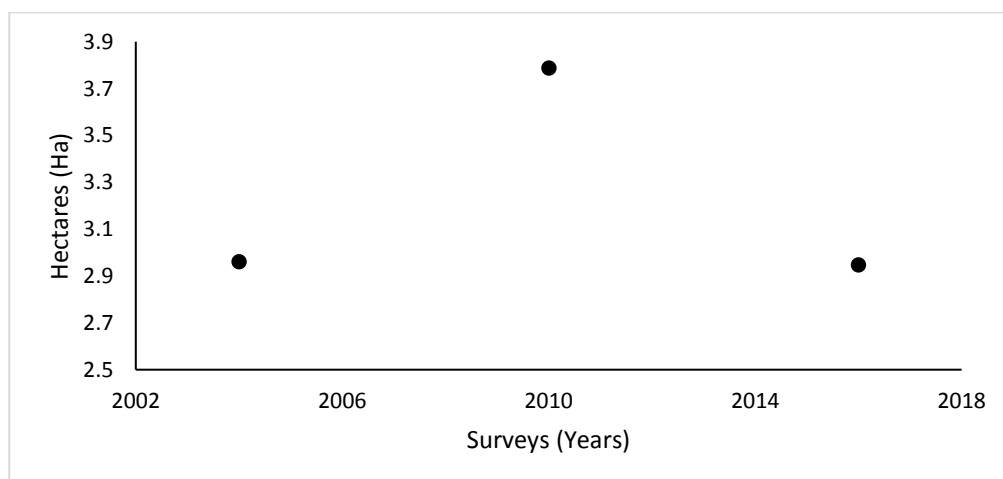
The results of the whole bed (i.e. the joint area of the north and south seagrass beds taken together) show that the 2016 survey had the lowest total area (2.95 ha) of *Z. marina* recorded in comparison with the 2004 and 2010 monitoring surveys (Figure 14). However, there are some possible issues regarding the mapping of the more southerly seagrass bed. In this area, the seagrass tends to exist as more isolated clusters, and differences in mapping during separate field events may result in variation where small clusters are either mapped individually or are mapped as a larger, single area. This variation is possible through differences in how the mapping protocol is implemented in the field and is most problematical where there are many small areas of seagrass in proximity to each other. The south bed is also more prone to wave action and is known to be variable in its density and patchiness of seagrass.

Figure 14 Total extent (ha) of intertidal *Zostera marina* from 2004-2016 (north and south beds combined). Data collected from field mapping of the seagrass bed during intertidal SAC monitoring events

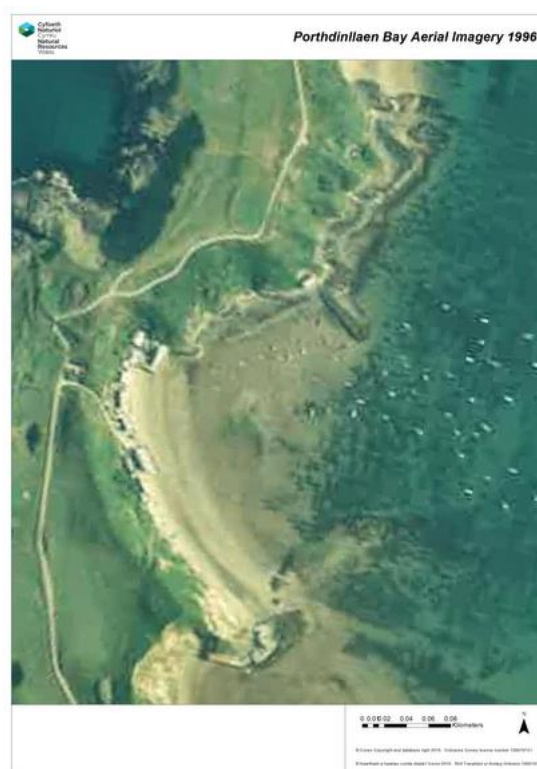
Figure 17 Extent of *Zostera marina* in Porth Dinllaen bay 1996

Removal of the sparser south seagrass bed showed that there was an overall expansion of over 0.5 ha in the core continuous bed from 2004 to 2016 (Figure 17).

Aerial images from 1993 and 1996 (Figures 16 and 17) also indicate that the extent (7.08 ha) from the Phase 1 survey was an approximation. Observations from the 1993 and 1996 images showed that the north seagrass bed was patchy with a less dense patch in the middle which separated two distinct patches. Comparing these images to the recent aerial images also revealed that the less dense patch is still visible within the 2013 aerial

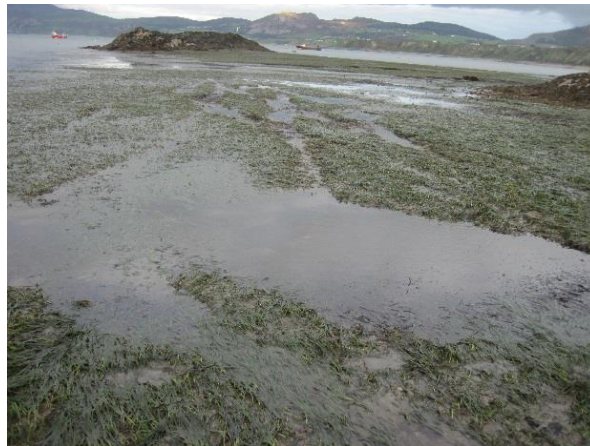
Figure 23 Tyre tracks observed over the seagrass, creating deep depressions (20160919 NL Porth Dinllaen 0475)

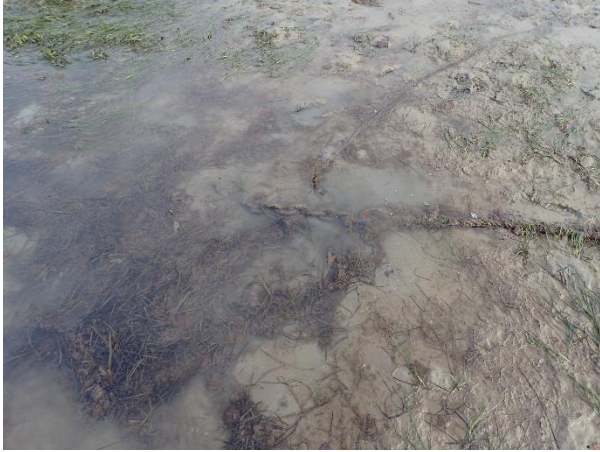
Figure 27 Damage caused by the chain of a mooring (20160919 BW Porth Dinllaen 0047)

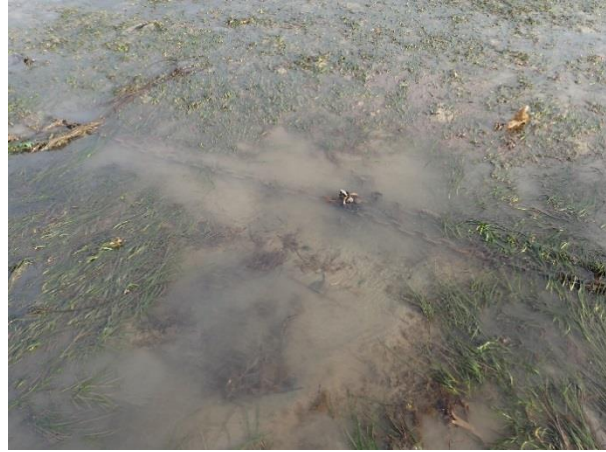
Figure 28 Plucking damage created by the mooring chains (20160919 BW Porth Dinllaen 0048)

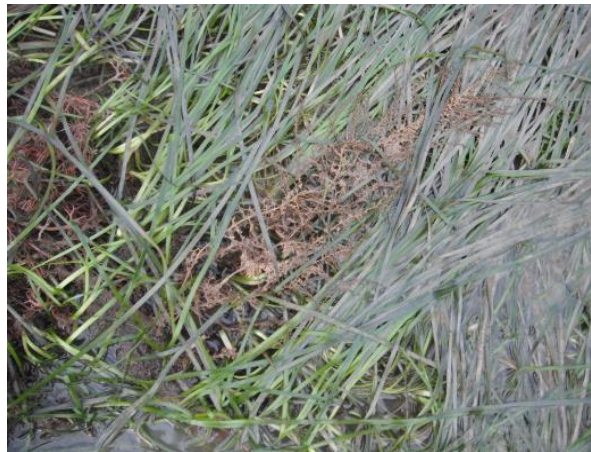
Sargassum muticum was also recorded as present within the seagrass bed (Figure 29), but no quantitative data were collected on the abundance of *S. muticum* within the intertidal seagrass meadow. Observations in 2010 suggested that scour marks become stonier due to winnowing of sand and mud, resulting in the opportunity for large plants of *S. muticum* to establish, which in turn may impact on *Z. marina* through shading the *Z. marina*. Gathering more quantitative data on the presence of *S. muticum* would aid in determining whether the *S. muticum* is increasing within the bay.

Figure 29 *Sargassum muticum* within the seagrass (20160919 LK Porth Dinllaen 2267)

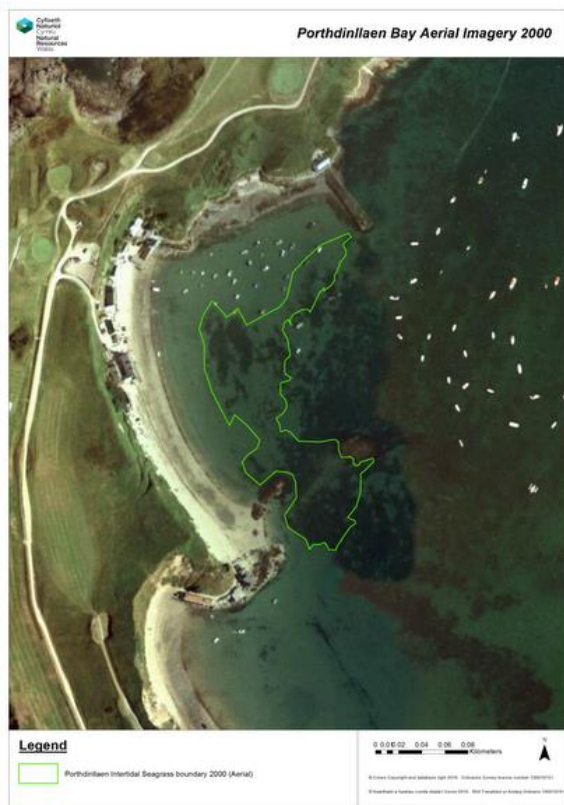
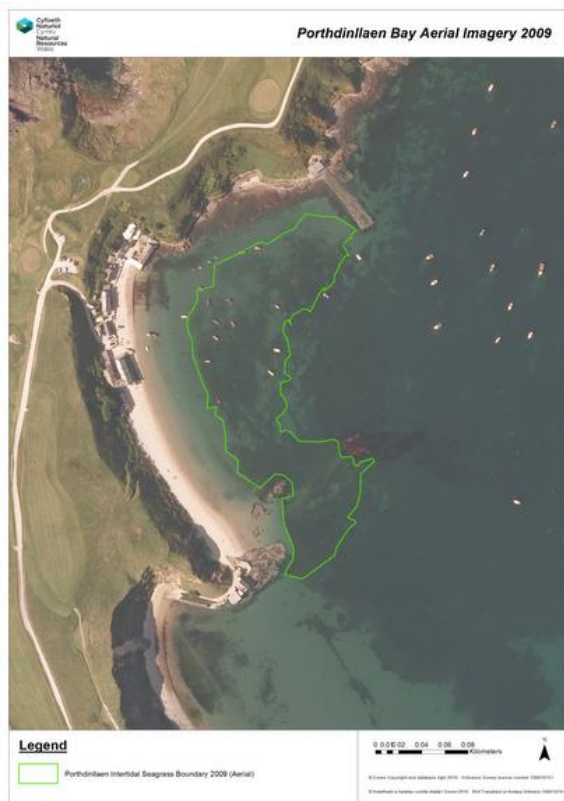
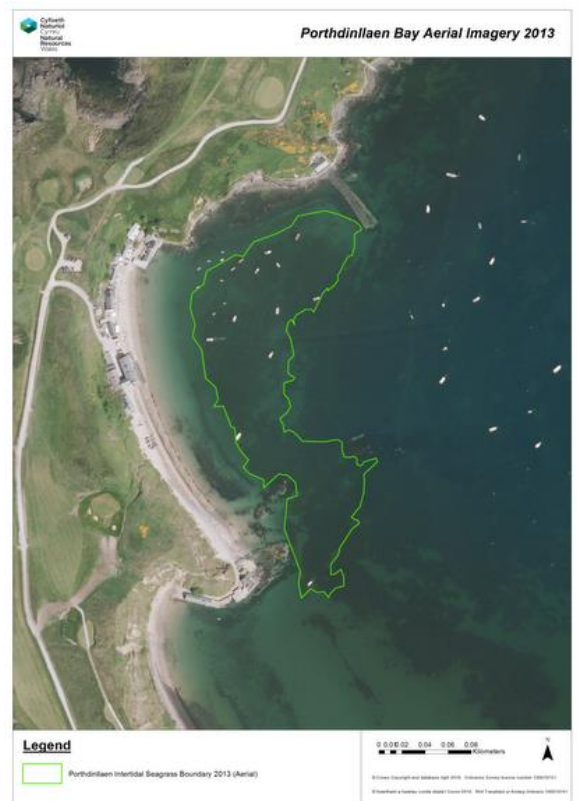
Polygons created for the aerial images (2000, 2006, 2010 and 2013) can be seen below.

The polygons of intertidal seagrass extent were created in ArcGIS from aerial images for the years 2000, 2006, 2009 and 2013 and are shown in Appendix 10. Polygons were only created for the more continuous north *Z. marina* bed and the same lower shore mask was used, to keep the seaward boundary consistent.
