Llyn Tegid Reservoir Safety Project

Phase 1 Habitat Survey Report for additional site areas and validation

September 2019

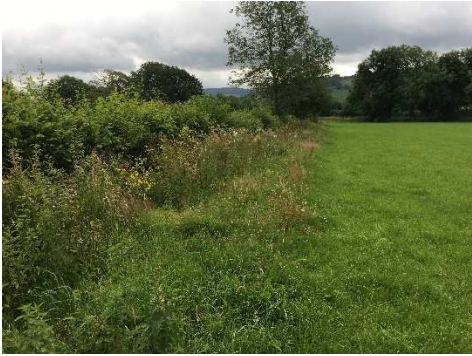
<p>TN 4</p>

<p>Shallow running ditch along the field boundary with adjacent rough unmanaged buffer. Species included hemlock water dropwort <i>Oenanthe crocata</i>, water mint <i>Mentha citrata</i>, monkeyflower <i>Mimulus guttatus</i> and meadow sweet. Adjacent young hazel <i>Corylus avellana</i> hedge located on the field boundary next to the ditch.</p>
<p>TN 5</p>

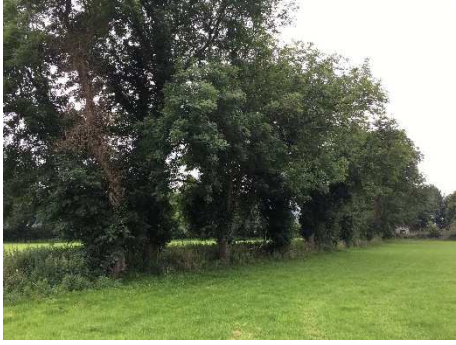
<p>Row of mature trees on field boundary. Most of the trees were ash with the occasional beech <i>Fagus sylvatica</i> tree. Some trees have suitability for roosting bats which contained potential roosting features (PRFs) such as cracks, knots and hollows within trees that could be used as bat roosts. Some trees covered in ivy, which may obscure any further PRFs.</p>
<p>TN 6</p>

- Bats – if any mature trees are affected by construction compounds or access routes then further detailed assessments will be required to assess the tree/s suitability to support bat roosts. If suitable and the tree will be impacted by proposed works, then further surveys will be required either through or in combination with tree climbing surveys to inspect PRFs followed by dawn/dusk emergent/re-entry surveys;. Any works that effects bat roosts should be undertaken under license from NRW;

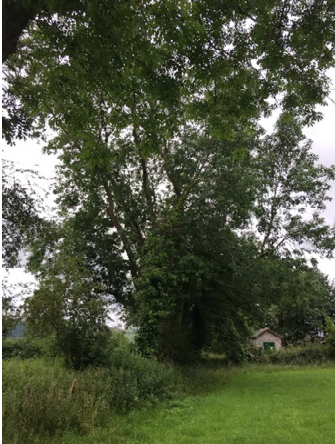
<p>Row of mature ash and beech trees with PRFs on field boundary.</p>
<p>TN 7</p>

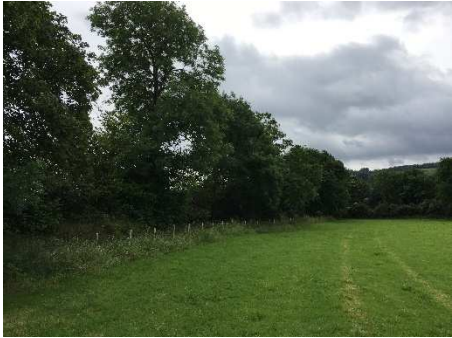
<p>Row of mature ash and beech trees with PRFs on field boundary.</p>

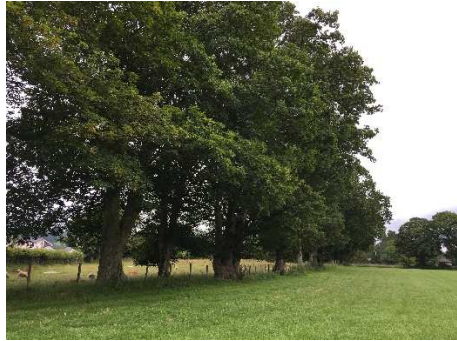
<p>TN 8</p>

<p>Row of mature, ash, oak <i>Quercus sp</i>, beech and sycamore <i>Acer pseudoplatanus</i> trees with PRFs on field boundary.</p>
<p>TN 9</p>

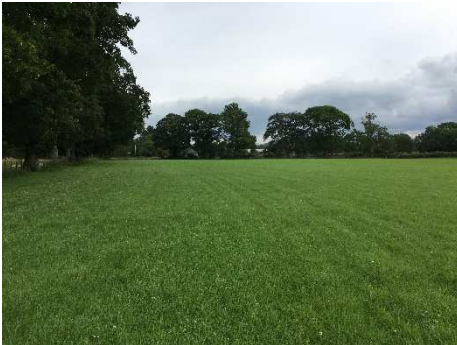
<p>Improved neutral grassland habitat that had been recently mown. Species diversity of grassland low, containing species such as perennial rye grass, white clover and occasional meadow buttercup.</p>
<p>TN 10</p>

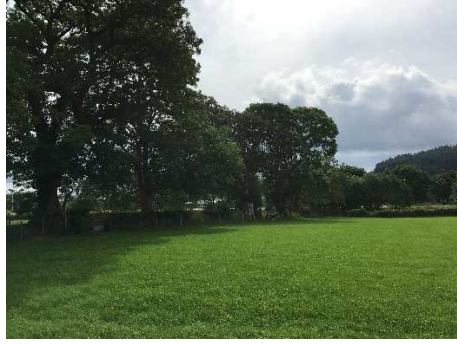
<p>Row of mature ash and oak trees on the northern boundary of the field with PRFs.</p>
<p>TN 11</p>

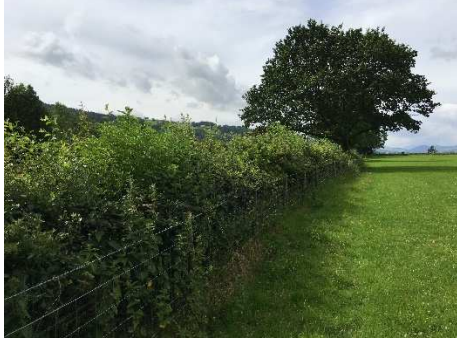
<p>Intact species poor hedgerow with trees on the boundary of the field. Good mixture of woody species such as hawthorn, hazel, blackthorn, elder <i>Sambucus nigra</i> and dog rose. Within hedgerow are semi mature ash trees. Understorey of hedgerow containing abundant nettle and common cleavers with red campion.</p>

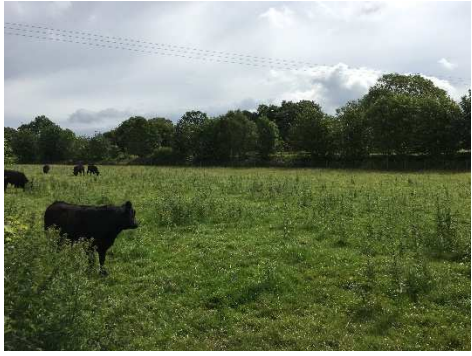
TN 12

<p>Improved neutral grassland habitat that at time of survey was being grazed by cattle. Scattered throughout field was frequent creeping thistle <i>Cirsium arvense</i>.</p>
TN 13

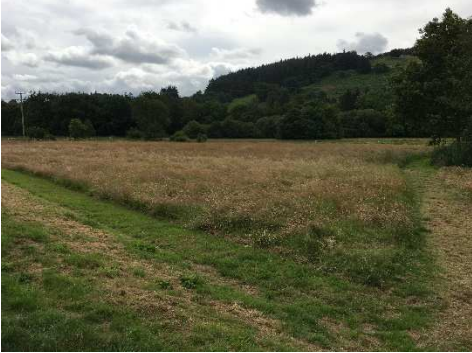
<p>Grassland area currently being used as meadow habitat. Grassland dominated by Yorkshire fog and common bent grasses. Mixed within the grassland was occasional greater birdsfoot trefoil <i>Lotus pedunculatus</i>.</p>
TN 14

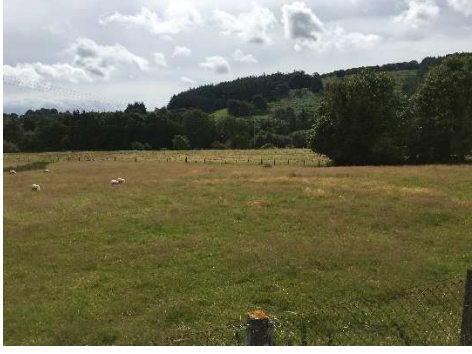
<p>Improved neutral grassland habitat that is currently being grazed by sheep. More diversity of grasses in these fields compared to others, including species such as common bent, Yorkshire fog, sweet vernal grass <i>Anthoxanthum odoratum</i>, crested dogstail <i>Cynosurus cristatus</i> and scattered creeping buttercup.</p>
TN 15

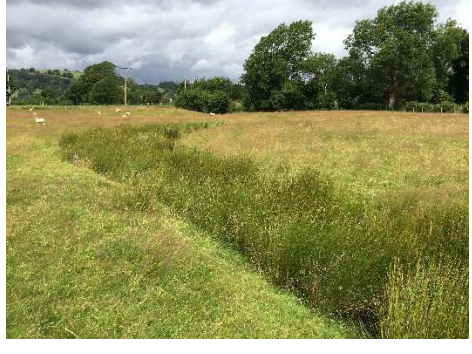
<p>Wet flush within field containing dominant soft rush <i>Juncus effusus</i>. Area surrounded by improved neutral grassland currently being grazed by sheep.</p>

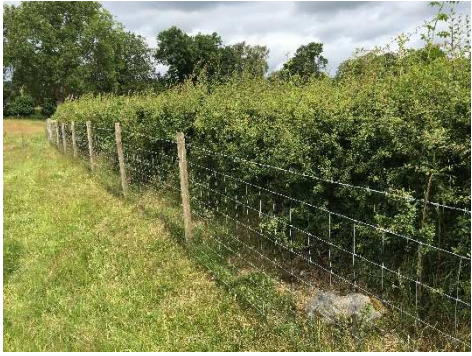
<p>TN 16</p>

<p>Species poor intact hedgerow separating field. Hedgerow dominated by hawthorn.</p>
<p>TN 17</p>

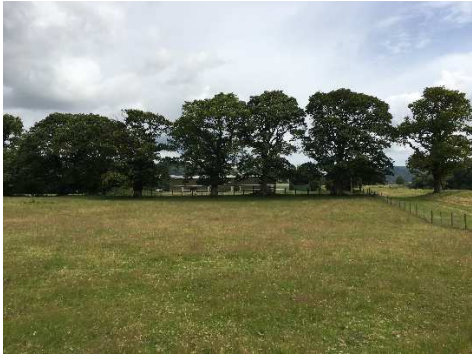
<p>Row of mature ash and oak trees on the northern boundary of field with PRFs.</p>
<p>TN 18</p>

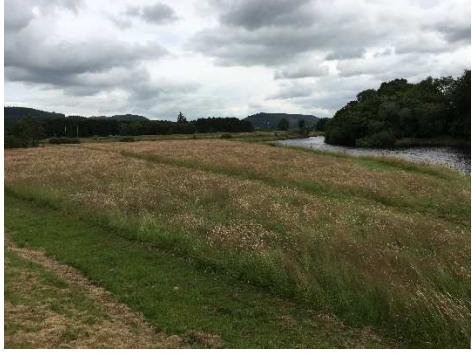
<p>Large area of meadow habitat adjacent to the river. Grasses such as Yorkshire fog and common bent dominate the sward with occasional greater birdsfoot trefoil.</p>
<p>TN 19</p>

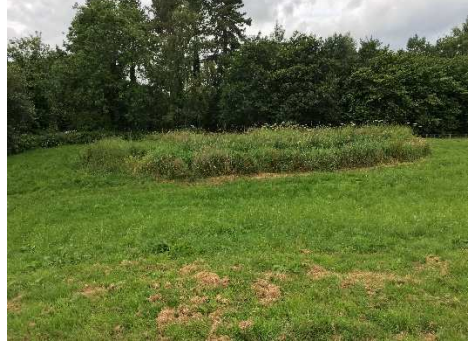
<p>Small pond at time of survey was dry. Vegetation dominated by common reed <i>Phragmites australis</i> and reedmace <i>Typha latifolia</i>. The remainder of the vegetation contained bramble and dominant common nettles.</p>

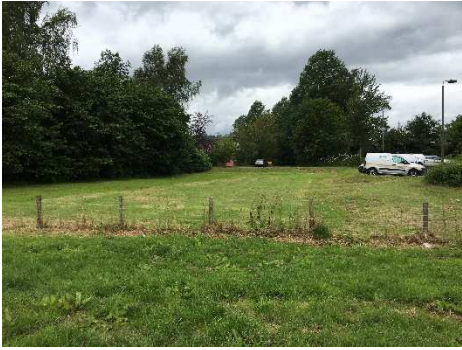
<p>TN 20</p>

<p>Recently mown grassland area adjacent to the Natural Resources Wales office proposed for a small satellite compound.</p>
<p>TN21</p>

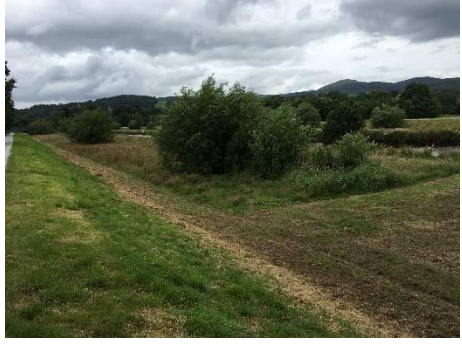
<p>Area of grassland habitat adjacent to the river. Grasses such as Yorkshire fog and common bent dominate the sward with occasional greater birdsfoot trefoil and scattered meadow buttercup. Scattered in the area was osier willow <i>Salix viminalis</i>.</p>
<p>TN22</p>

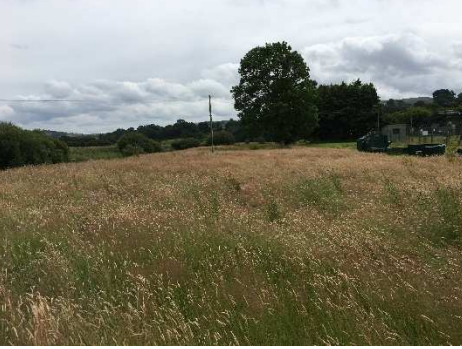
<p>Area of grassland habitat on island adjacent to the river. Sward dominated by Yorkshire fog and common bent grasses with occasional birdsfoot trefoil, back knapweed and selfheal <i>Prunella vulgaris</i>.</p>
<p>TN23</p>

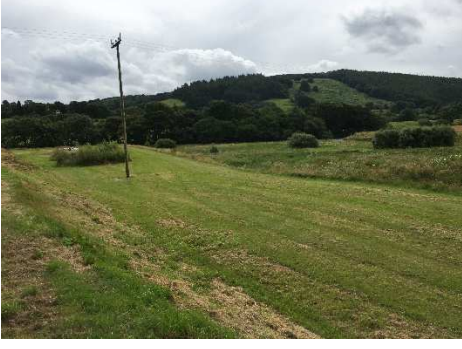
<p>Large open area of managed grassland habitat. Sward dominated by Yorkshire fog and common bent grasses.</p>
