# Llyn Goddionduon

Replacement of existing reservoir embankment and overflow

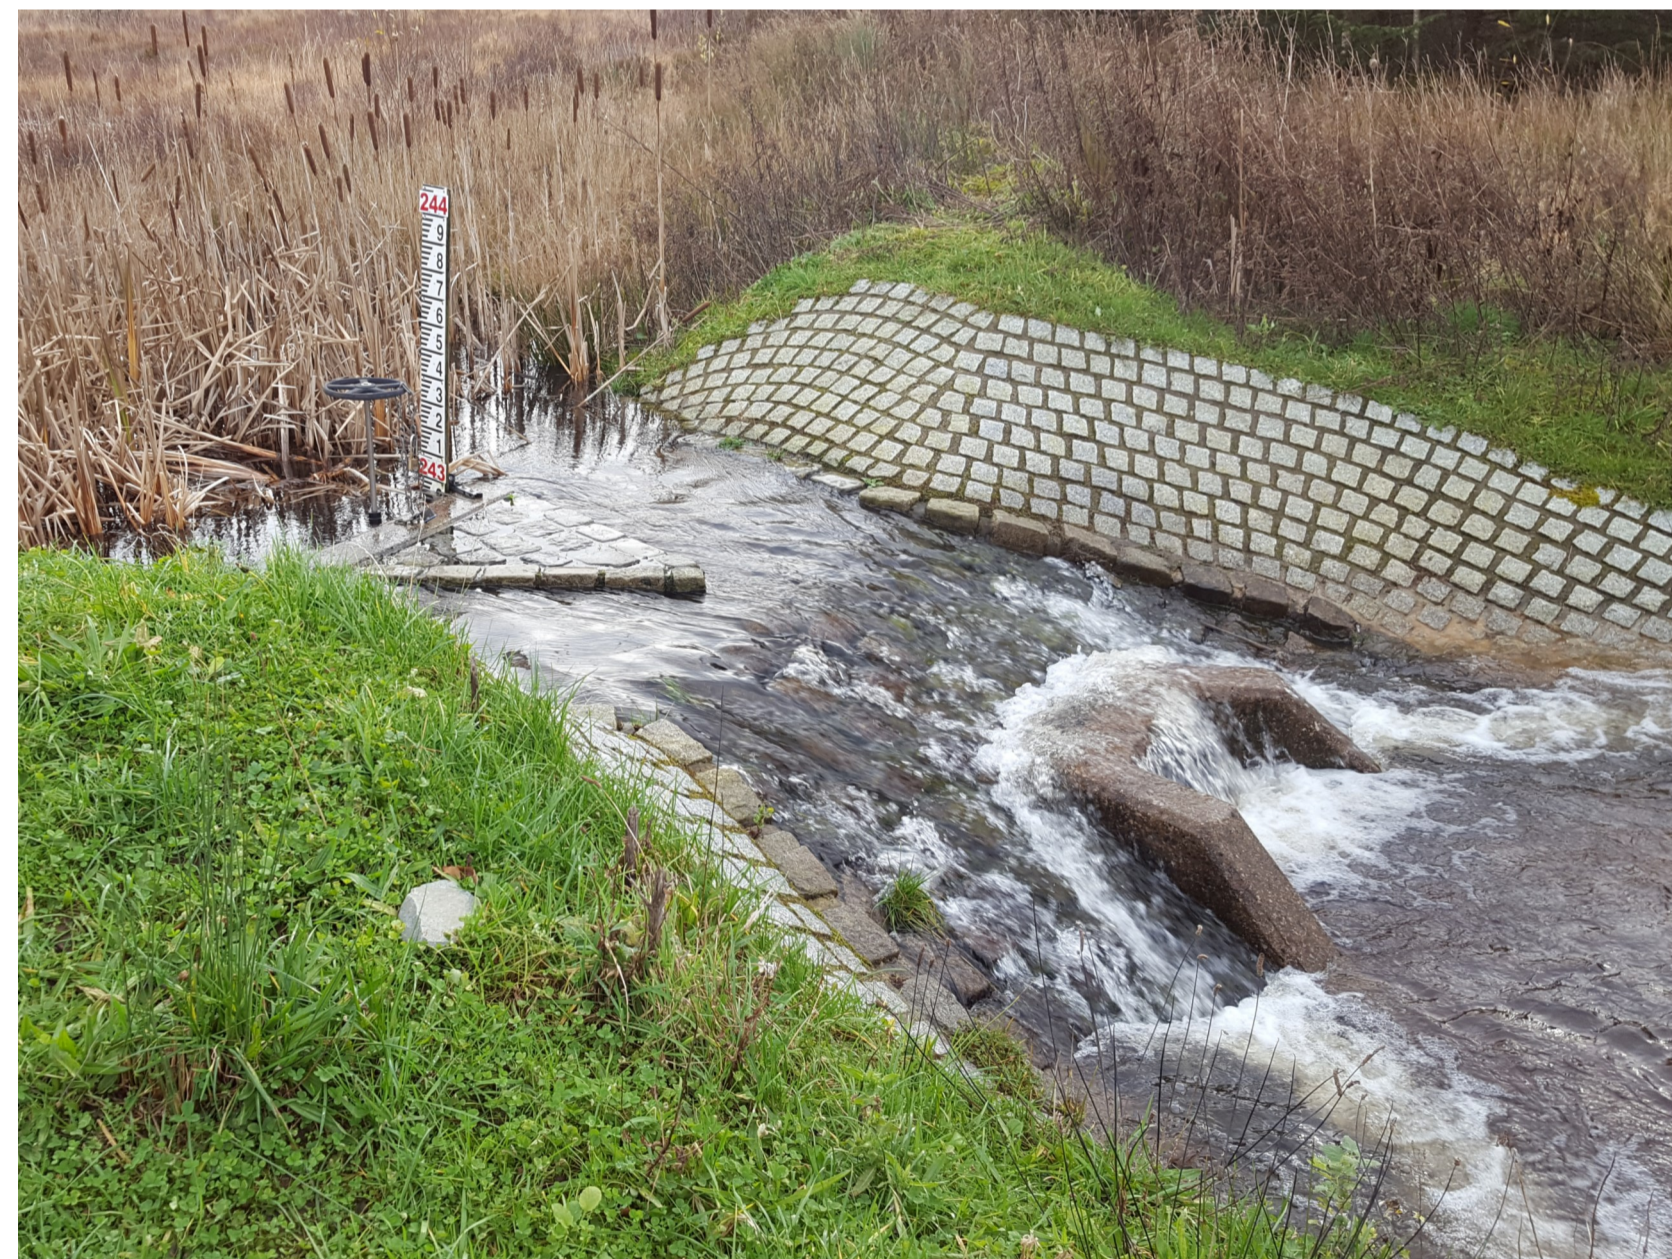
Gorlif presennol y gronfa ddŵr, i'w symud oddi yno  
Existing reservoir overflow, to be removed

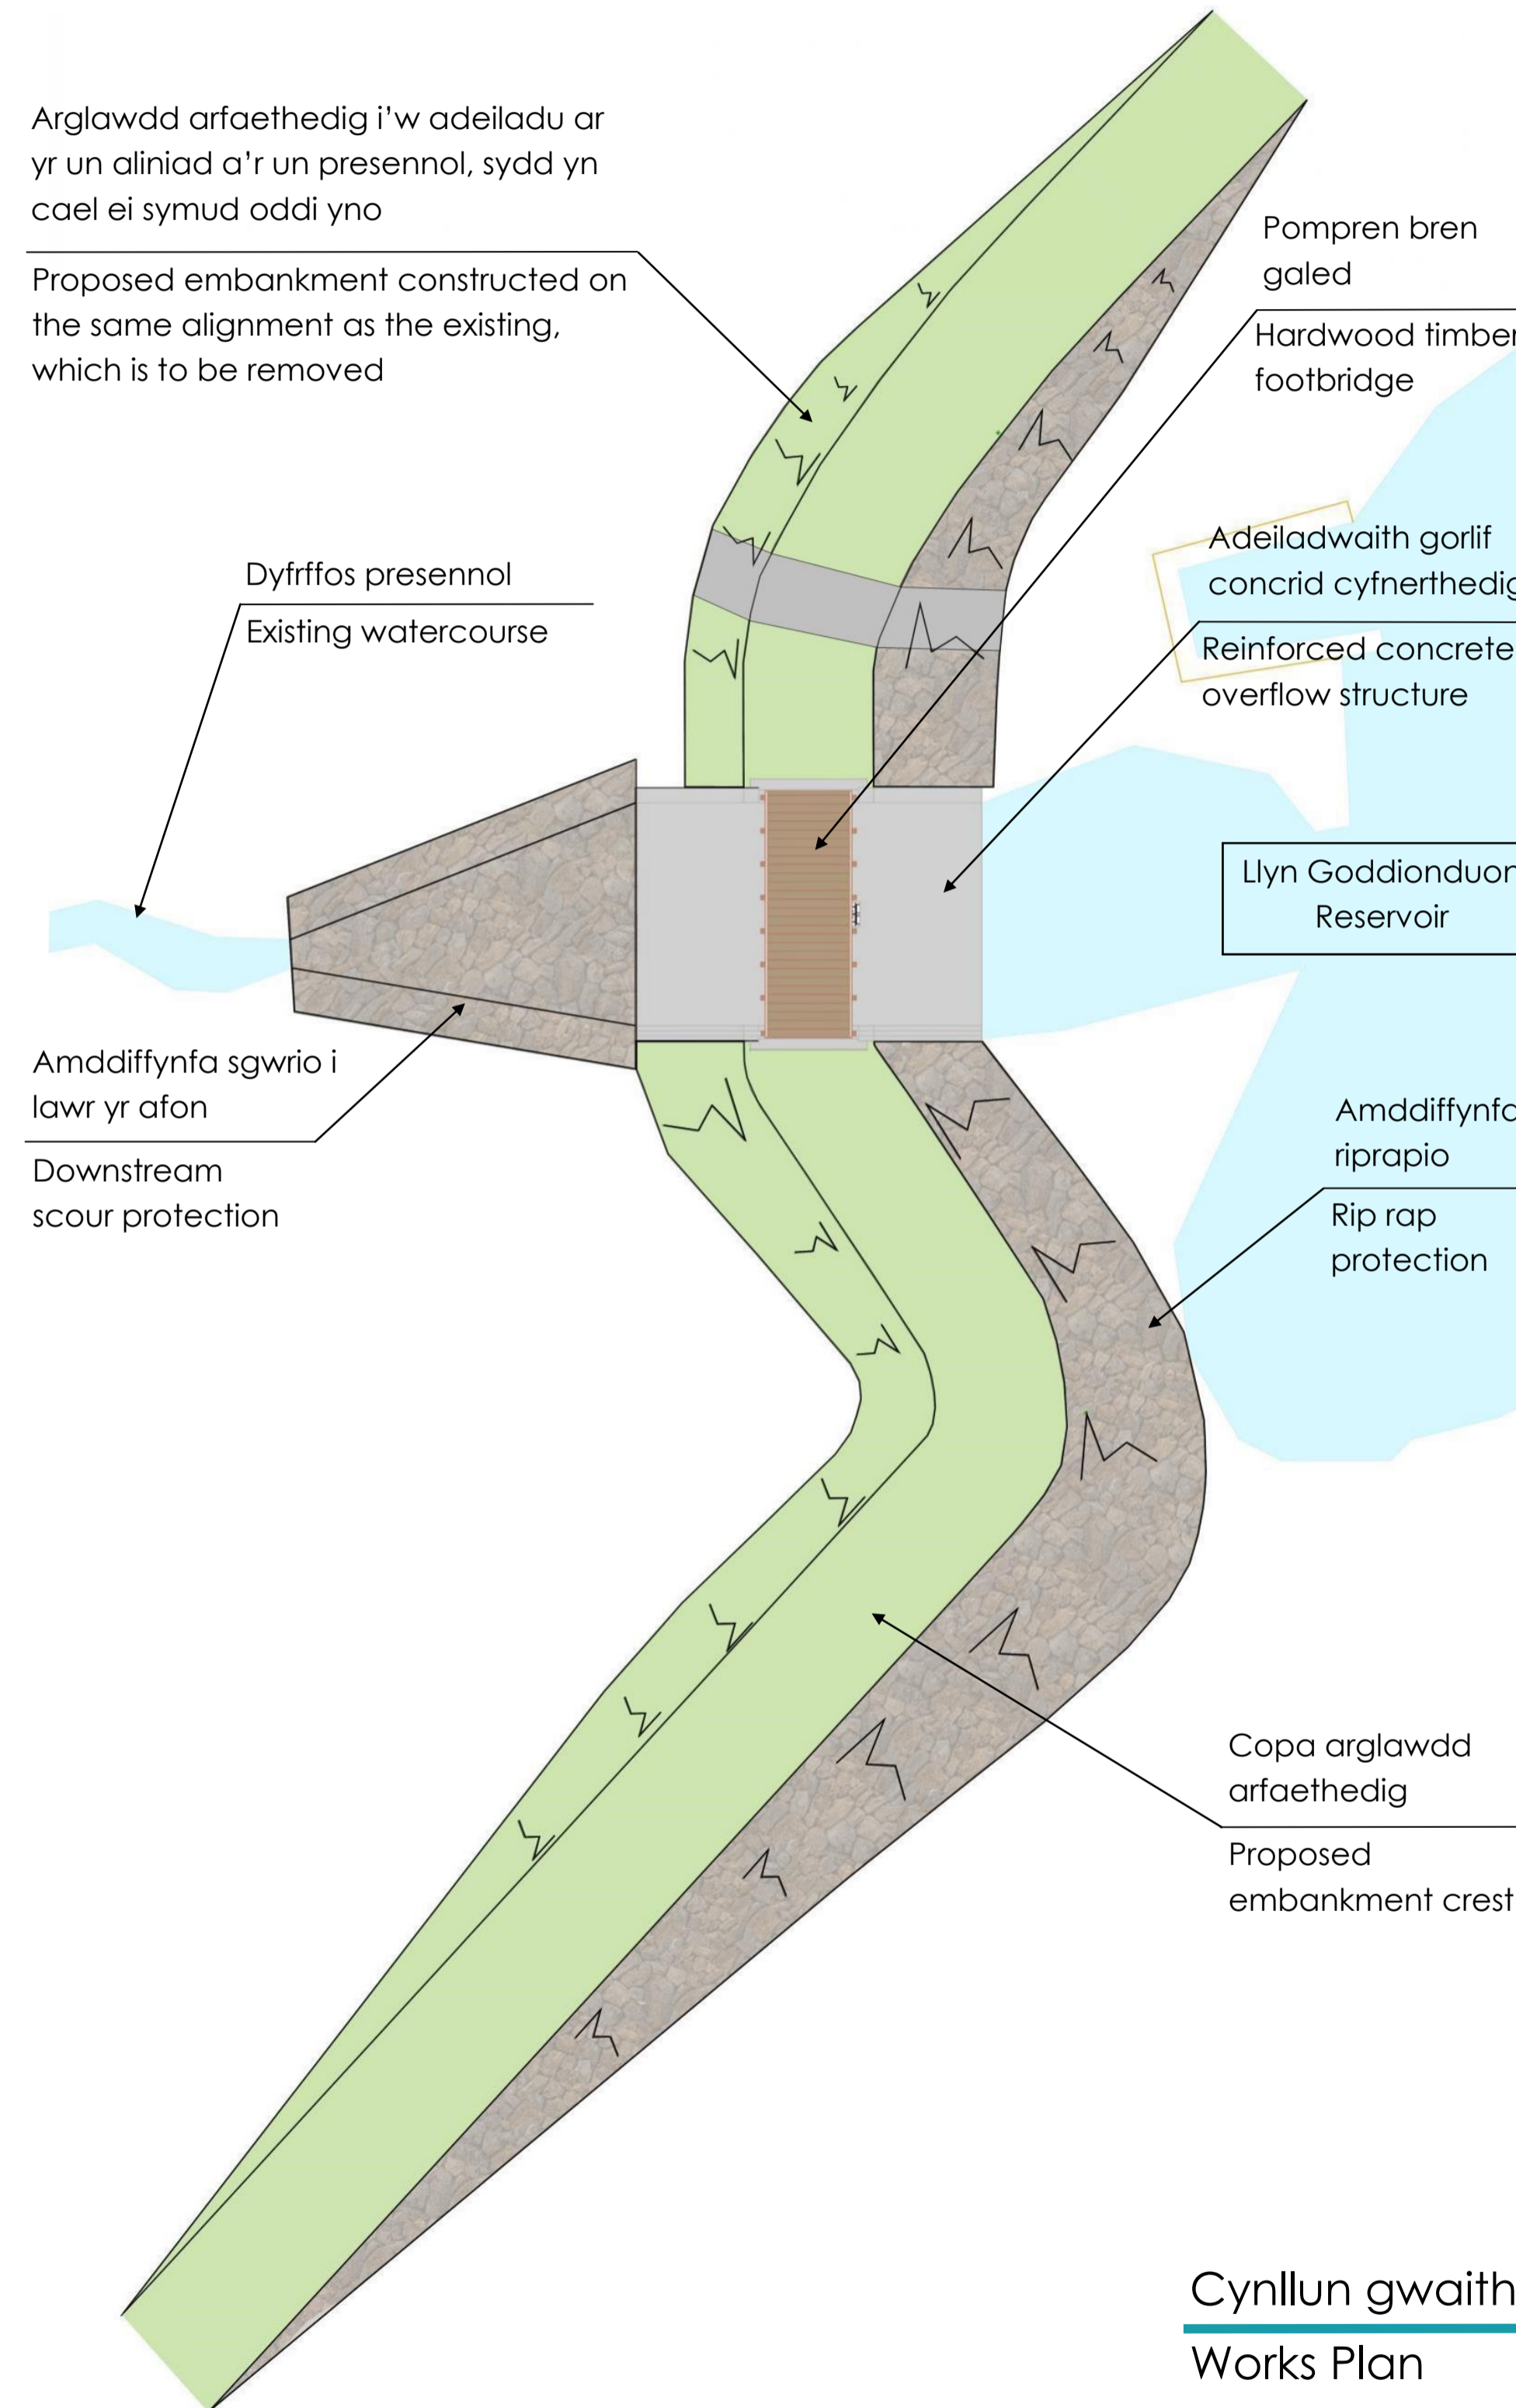
Copa glaswellt a llethr i lawr yr afon wedi'i atgyfnerthu  
Reinforced grass crest and downstream slope

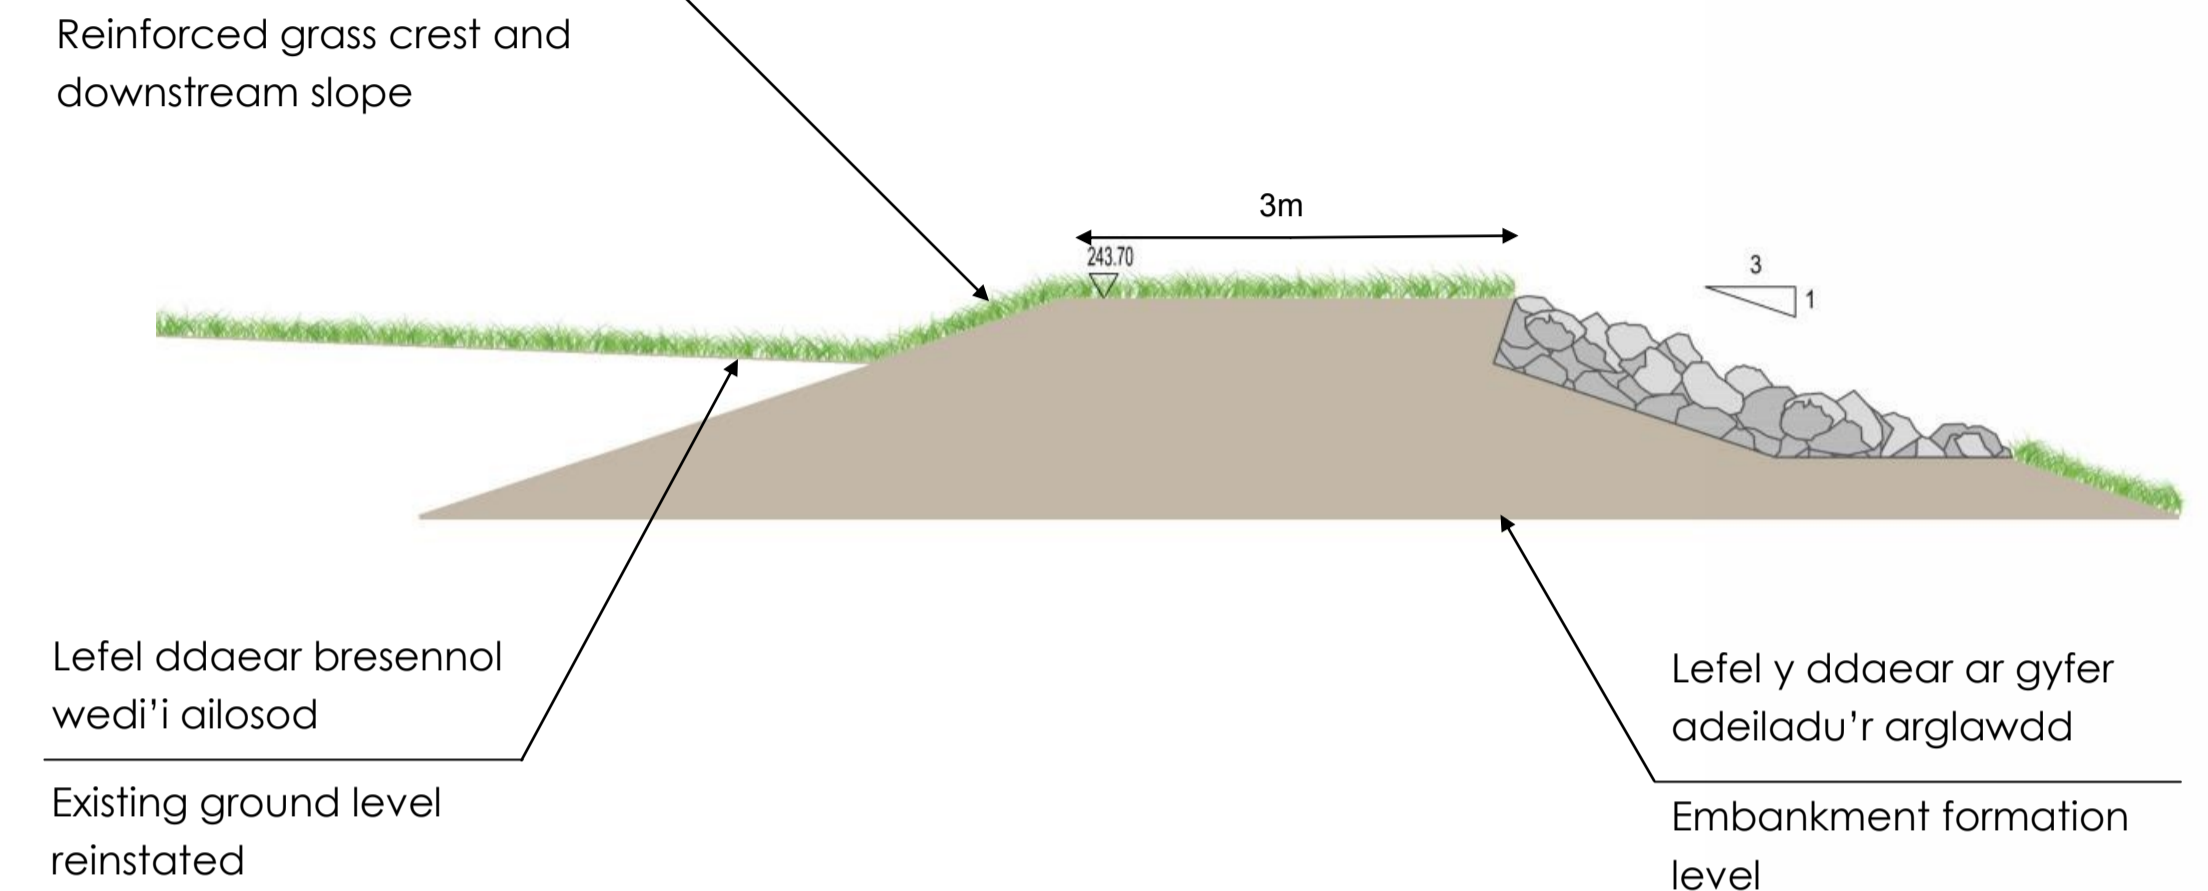
Rhan arferol, arglawdd cronfa ddŵr arfaethedig  
Typical section, proposed reservoir embankment

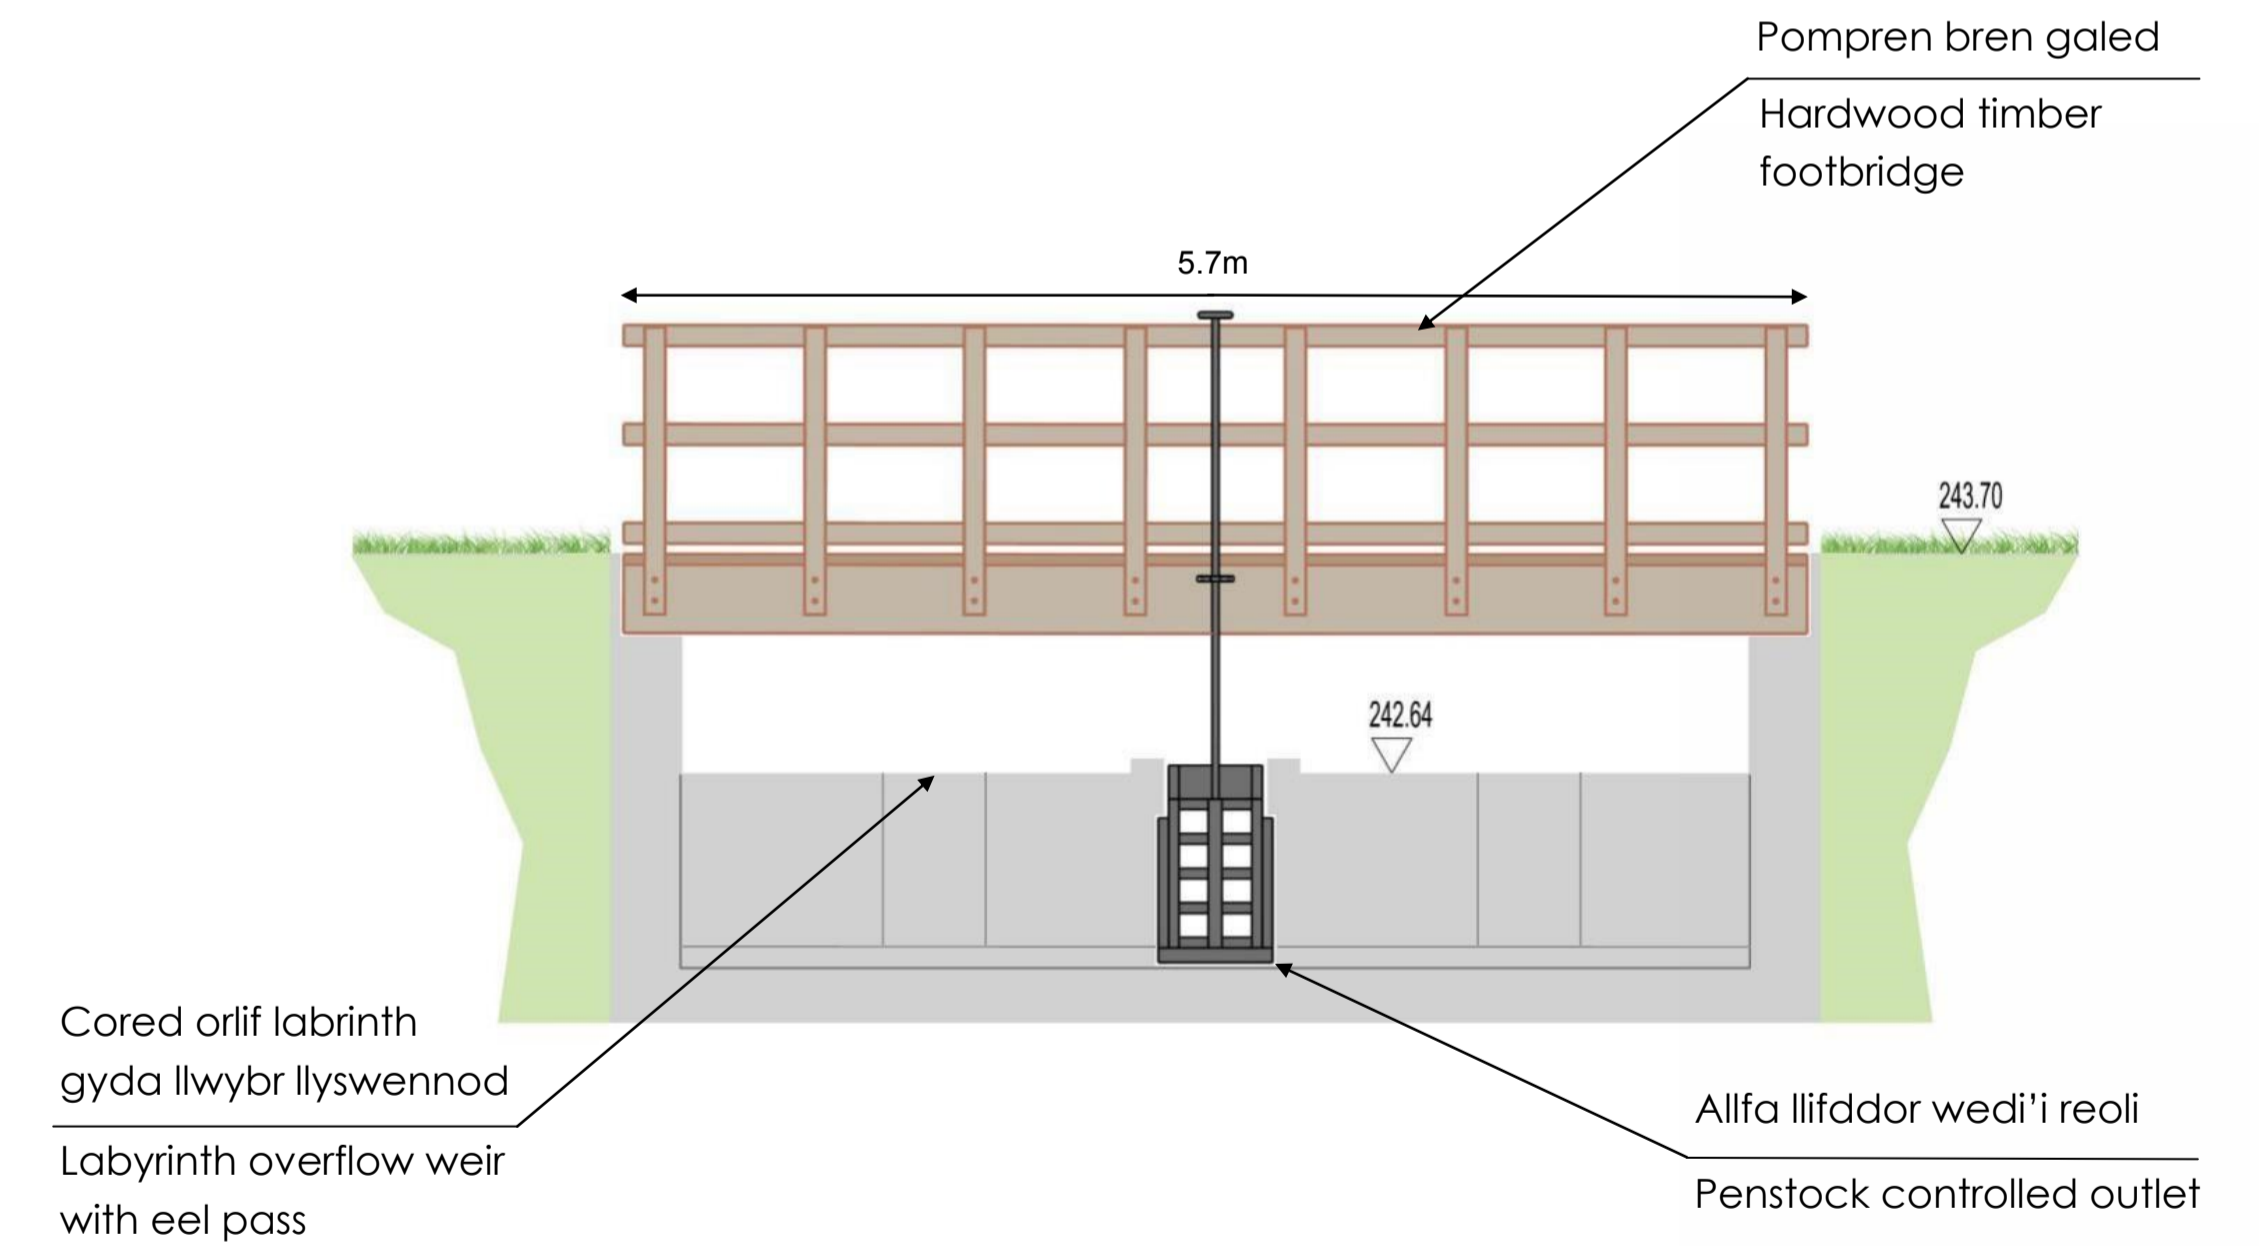
Adeiladwaith gorlif concrid cyfnerthedig gyda phompren arfaethedig  
Proposed reinforced concrete overflow structure with timber footbridge
